# BUILDING SURVEY REPORT

**PROPERTY** 28 Example Street  
Sample  
UK  
EX1 2EX

**SURVEY DATE** 01/01/2027

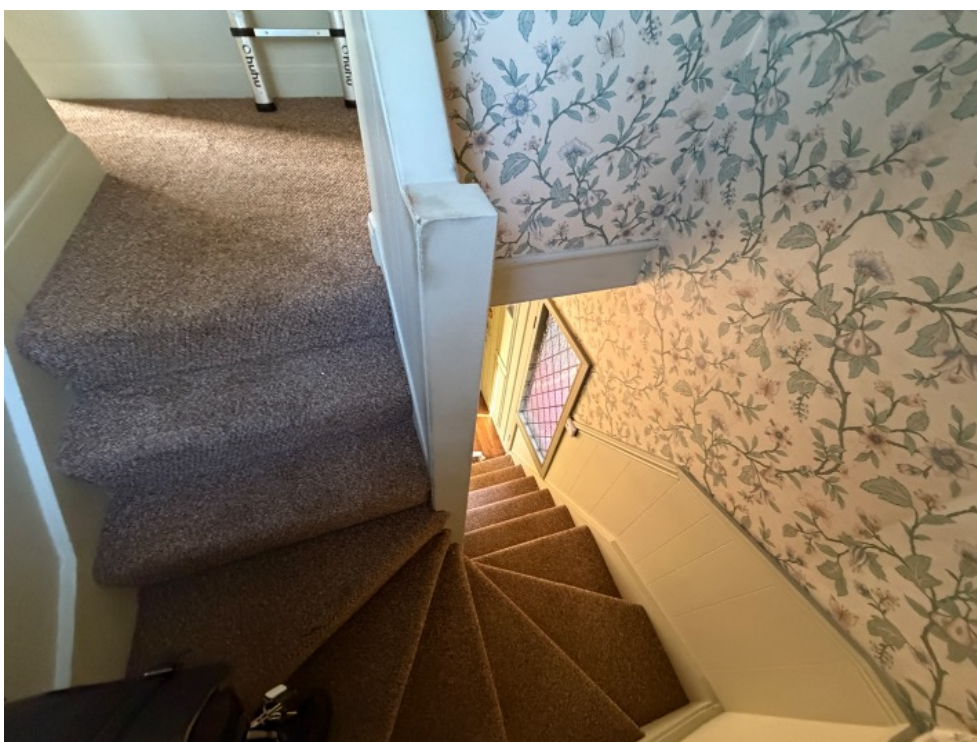
Lack of handrail to stairwell

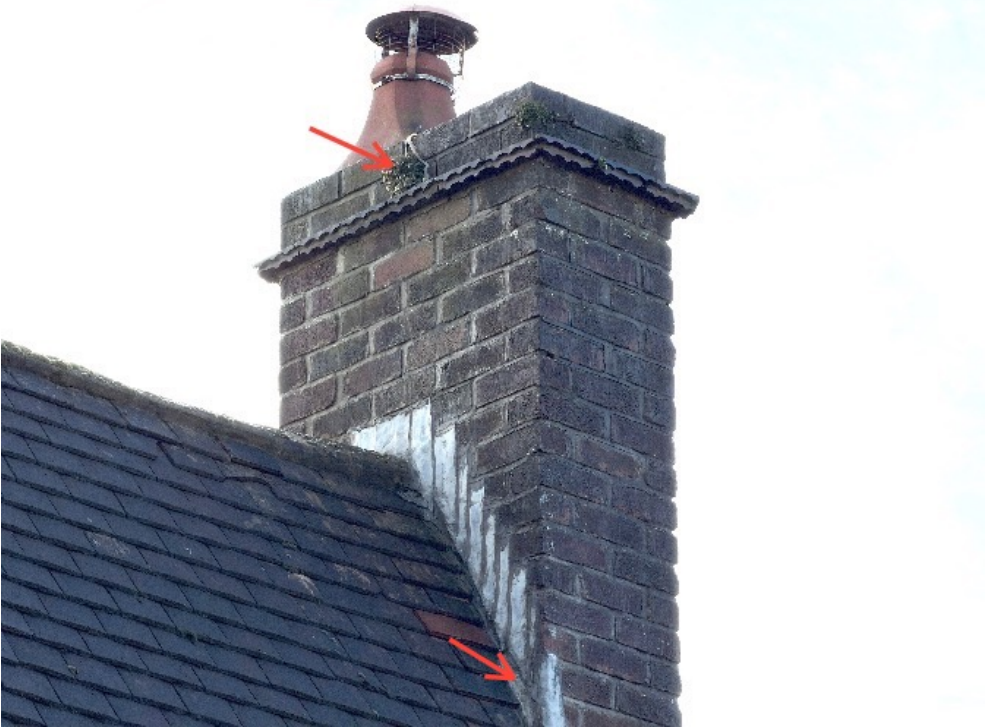
| <b>Condition</b> | <p>The mortar flashing detail at the base of the chimney stack exhibits unsightly and excessive use of external sealant, suggesting either poor original installation or a subsequent remedial attempt to address defects.</p> <p>The pots have rain cowls correctly fitted to allow flue gases to escape but prevent vertical rain entering the flue line.</p> <p>The chimney stacks were observed to have missing sections of mortar between the brickwork, with areas of vegetation growth present in the joints and on the surface. This deterioration is typically due to prolonged weathering and a lack of regular maintenance. Exposure to freeze-thaw cycles causes mortar to degrade over time, and the presence of vegetation such as moss or small plants often indicates that moisture is being retained within the structure. The damaged mortar may allow moisture ingress leading to internal dampness or timber decay within the roof space where the stack penetrates the structure.</p> <p>Internal damp staining and high moisture readings have been observed in areas corresponding with the chimney breast and roof timbers adjacent to the right-hand chimney stack. The exact source of the moisture ingress is not visibly identifiable from within the property. However, it is likely attributable to defective external elements associated with the chimney stack such as damaged or missing mortar pointing, fractured render, vegetation growth, or failed lead flashing.</p> <p>A roof-level inspection by a qualified roofing contractor is recommended to assess the condition of the right-hand chimney stack. This should include:</p> <ul style="list-style-type: none"> <li>- A full check of lead flashings, mortar pointing and pointing</li> </ul> | | |

| | <p>View of right side chimney stack - vegetation growth - unsightly lead sealant</p> |

| <b>Action Required</b> | <p>A competent contractor should remove all vegetation from the stack and the mortar joints should be raked out and repointed using a suitable mortar mix.</p> <p>The chimney stack should be regularly monitored for any indications of damage, instability or other defects. You should carry out a thorough visual inspection at least once a year, ideally in the Spring, and ideally at roof level, to identify and repair any damage that could have been caused by winter weather.</p> <p>Missing, loose or defective mortar should be repointed as necessary.</p> <p>It is advisable to fit cowls on the top of the pots of any open flues.</p> |

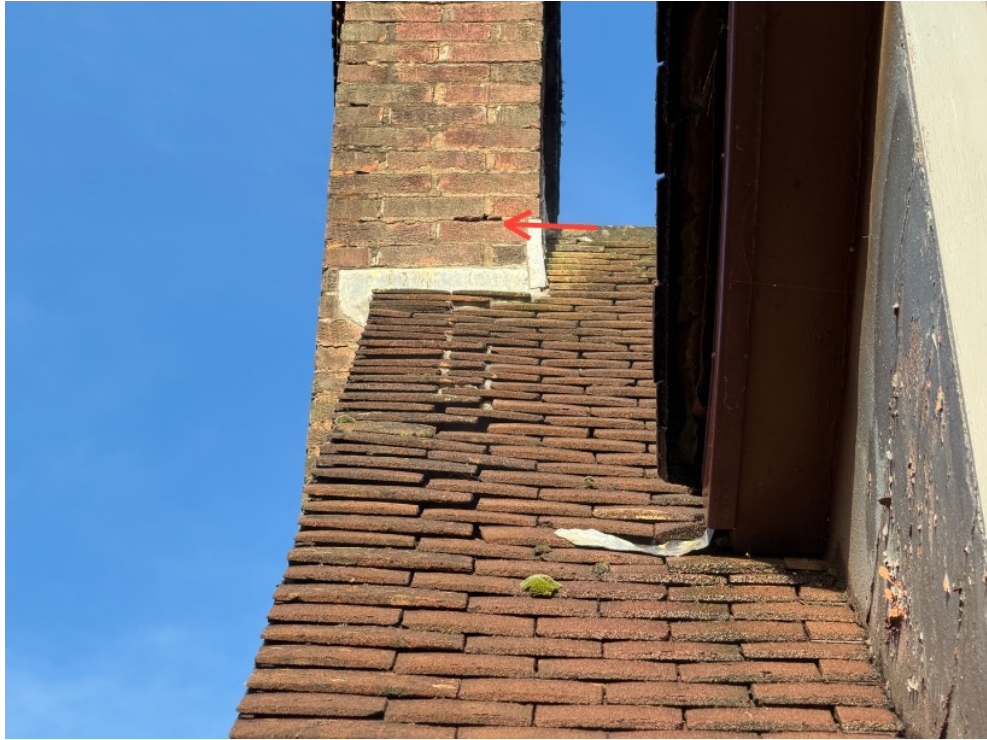
View of right side chimney - missing section of mortar

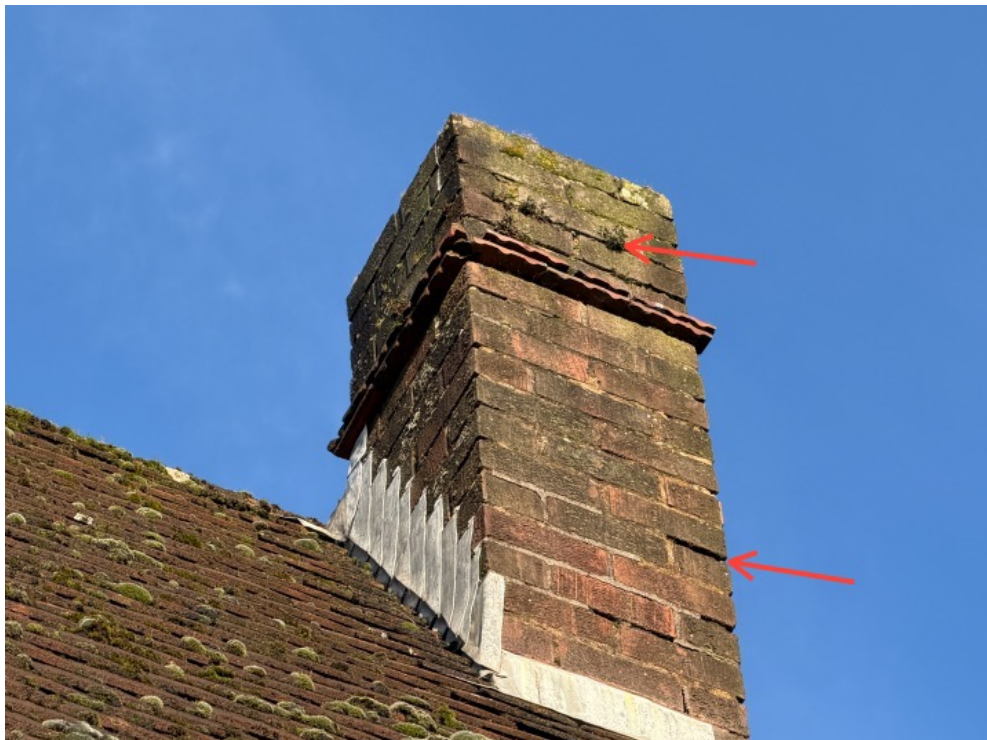
Left side chimney - vegetation and mortar missing

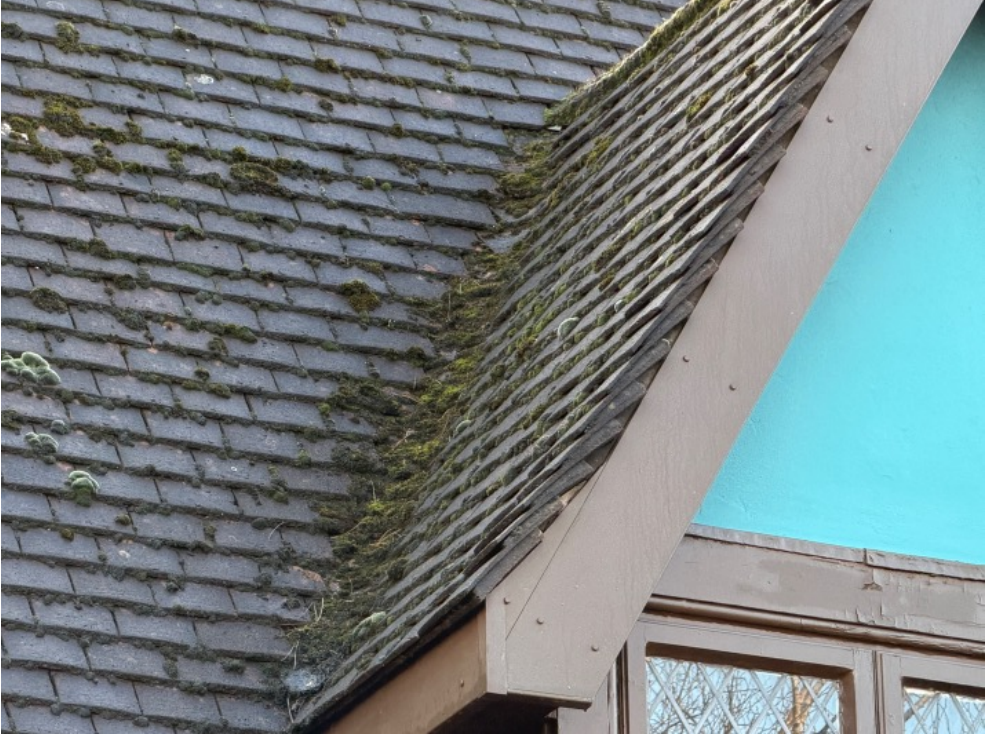
| <p><b>Condition</b></p> | <p><b>Pitched Sections</b></p> <p>No evidence was seen of unusual sagging or other movement which might indicate that the primary roof structure and dormer windows are failing.</p> <p>Moss and lichen growth were noted across both roof pitches and within the valley gutter sections. The accumulation appears moderate to heavy in certain areas, particularly where water runoff is slow-moving or where shade promotes biological growth. Valley gutters, by their nature, are more prone to such accumulation due to the convergence of water flow and debris. If left unmanaged, moss and lichen can retain moisture against roof tiles, leading to accelerated weathering or frost damage, particularly in freeze/thaw conditions. Also lead to issues such as blocking water runoff routes including valley gutters and rainwater downpipes, increasing the risk of water ingress into the roof structure or eaves, conceal underlying defects such as cracked, displaced, or slipped tiles, and promote the growth of roots or detritus, causing disruption to flashing or gutter linings.</p> <p>A number of slipped, chipped, and cracked tiles were observed on the main roof pitches. Additionally, various tiles appear to have been replaced, suggesting previous roof maintenance or repair attempts. Internally, staining and water damage were noted to ceiling and wall finishes beneath these areas.</p> <p>Damage to roof tiles is commonly caused by weathering, impact damage, poor-quality materials, or movement within the roof structure. Slipped tiles may result from corroded or broken fixings, or deterioration of the nibs/hooks that secure them in place. The presence of replaced tiles may indicate previous leaks or repairs, potentially carried out as spot fixes rather than comprehensive roofing works. Wide gaps were observed between several roof tiles across the main roof slopes. These joints appear uneven and larger than is typical for this type of roof covering.</p> <p>It was noted that the roof tiles to the rear gable end do not oversail the bargeboard sufficiently. The tile edges are near flush with the bargeboard, or in some areas fall short, providing inadequate projection over the fascia and wall below.</p> <p>The lack of tile oversail may be the result of poor detailing during re-roofing works, or inadequate installation of more modern UPVC bargeboards.</p> <p>Insufficient oversail allows rainwater to run directly down the face of the bargeboard and wall, rather than being directed into the rainwater guttering.</p> <p>The mono-pitched roof to the side elevation appears to lack sufficient slope. Evidence of water ingress was observed beneath the roof tiles, with staining and elevated moisture levels recorded to the roof felt and supporting timber structure beneath.</p> <p>The observed issue is due to an inadequate pitch to the mono-pitched roof. Pitched tile roof coverings require a minimum angle to ensure proper water run-off. If the pitch is too shallow, water can penetrate between the laps of the tiles, eventually reaching the underfelt and internal timbers. This condition may be original to the construction or due to a later roof modification or extension where pitch considerations were overlooked.</p> |

| | <p style="text-align: center;">Moss evidence to roof covering</p> |

| <p><b>Action Required</b></p> | <p>Removal of moss and lichen using appropriate soft-brush or biocidal treatment (not pressure washing, which may damage tiles).<br/> Inspection of the valley gutters for blockages, standing water, and damage to the lining. Check of roof tiles and flashing beneath the moss to identify any hidden damage.<br/> Ongoing maintenance may include annual roof inspections and application of preventative treatments to reduce regrowth.</p> <p>A roof-level inspection by a competent roofing contractor is strongly recommended to:</p> <ul style="list-style-type: none"> <li>•Fully assess the condition of the tile coverings, underlay, and roof structure.</li> <li>•Repair or replace slipped, cracked, or chipped tiles and check for consistency in previous repairs.</li> <li>•Investigate flashing and roof junctions, particularly in areas where water ingress has occurred internally.</li> <li>•Ensure that replacement tiles are well-matched and securely fixed to prevent future displacement.</li> </ul> <p>Assess the pitch of the mono-pitched roof and confirm whether it meets the minimum requirements for the installed roof covering (typically 20°–30° for interlocking tiles, depending on manufacturer). Consider re-covering the roof with a suitable low-pitch roofing system, such as single ply membrane, metal sheet, or proprietary low-pitch tile or slate products, if the existing tiles are unsuitable.</p> |

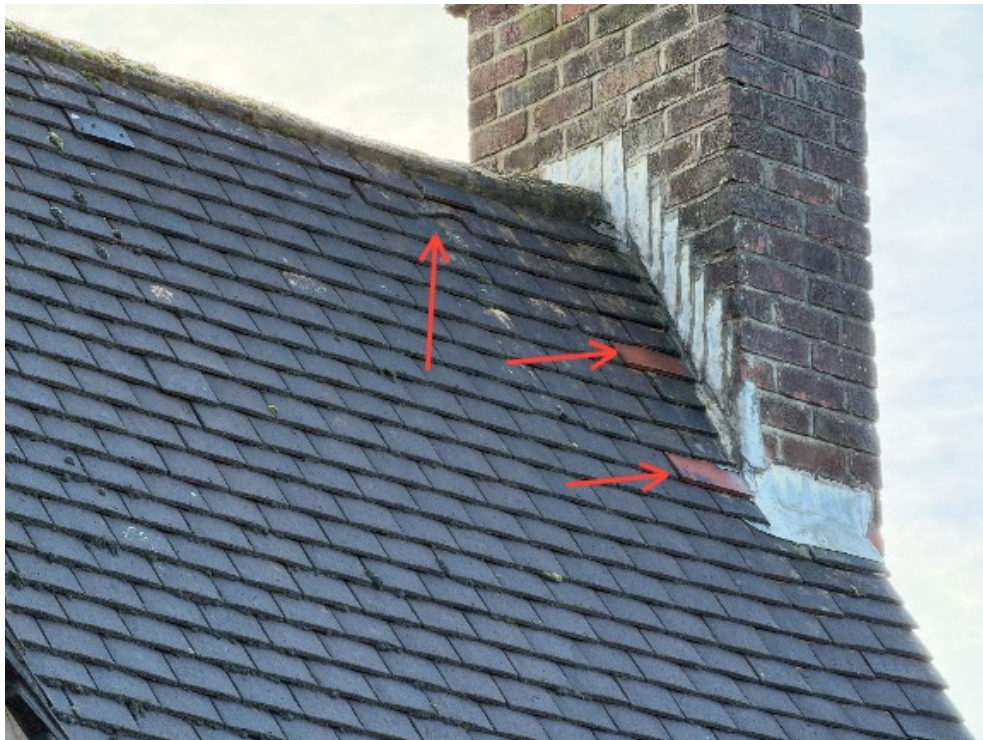
Damaged tile - roof repair sections

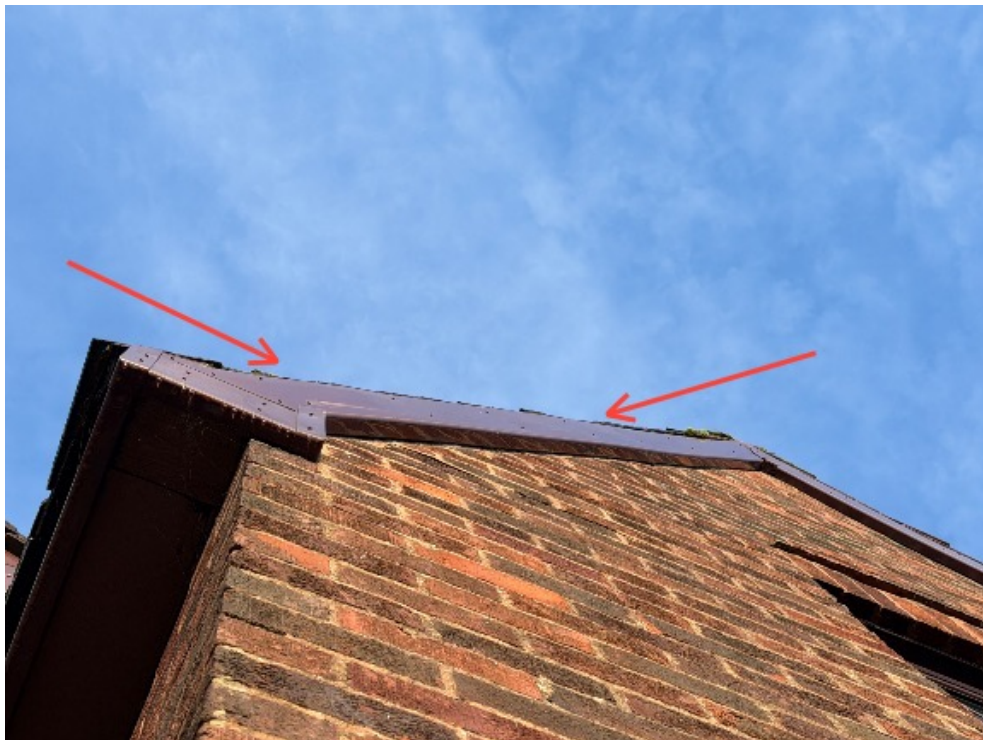
Lack of tile oversail to rear gable end bargeboard

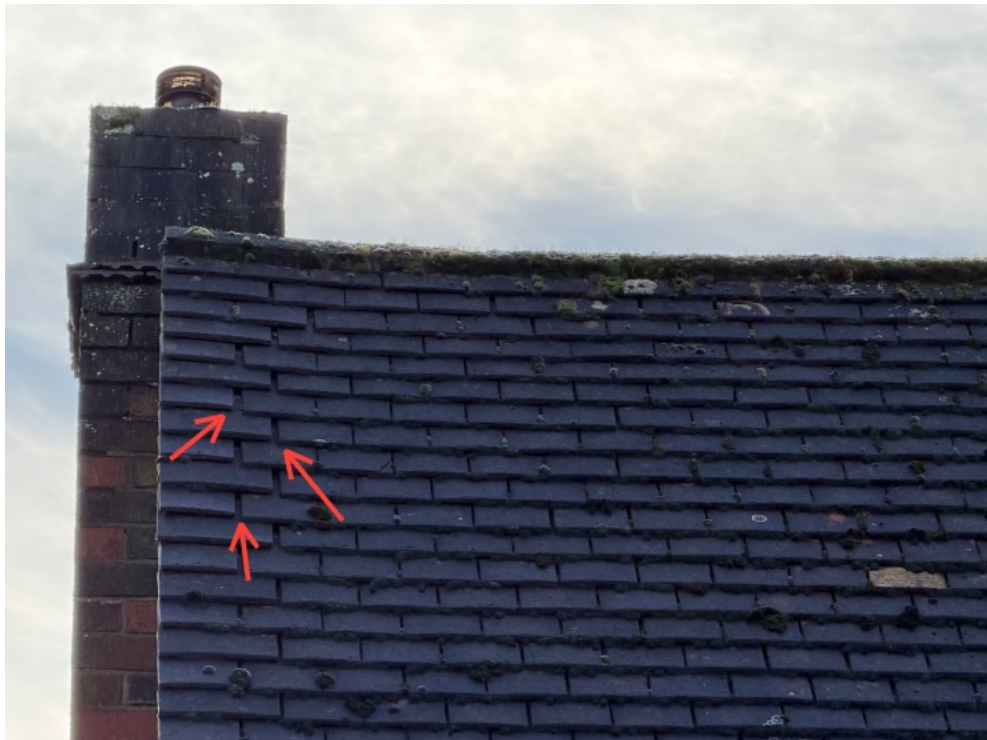
Wide spacing between tile joints

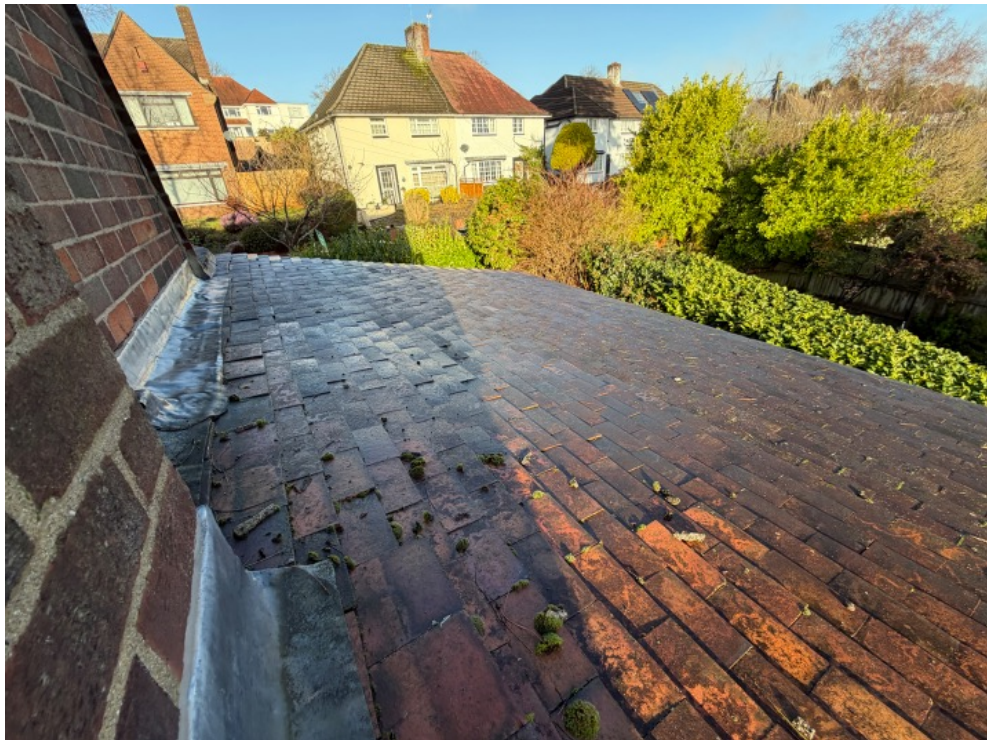
Lack of effective pitch to side roof

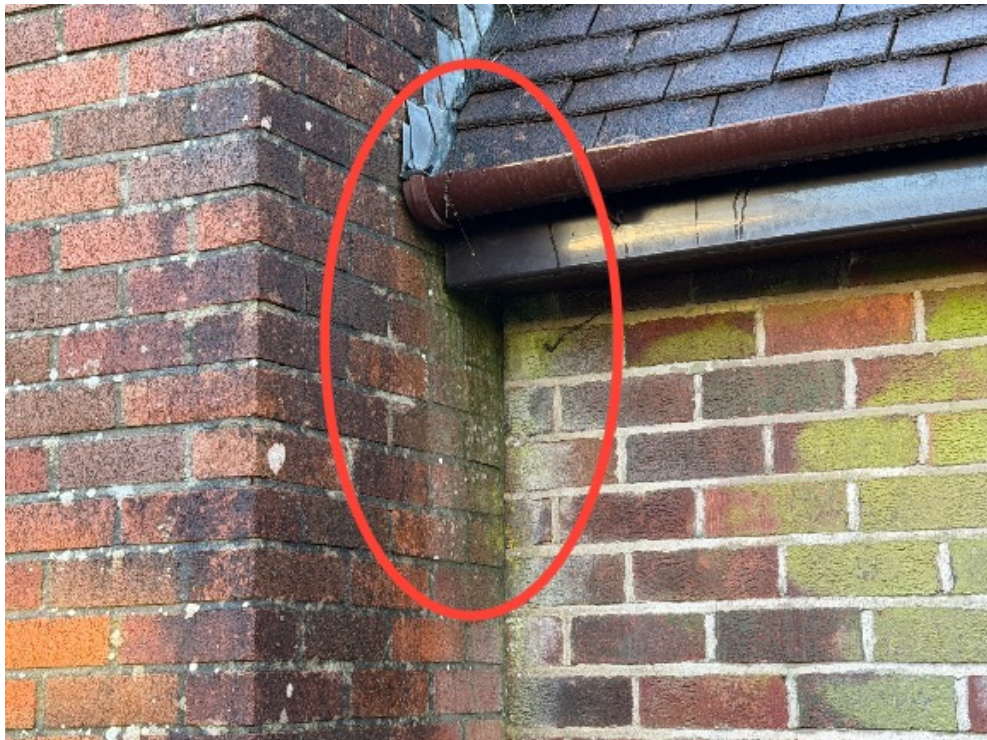
| <b>Condition</b> | <p>The gutters around the property are mostly serviceable and appear to be intact. However, localised staining was observed to the external wall below the front left gutter, indicating that overflowing may have occurred. A contributing factor appears to be moss accumulation on the roof tiles, which can obstruct the free flow of rainwater into the gutters.</p> <p>All gulleys require regular clearing of any debris that will accumulate over relatively short periods of time.</p> <p>A downpipe servicing the left side mono-pitch roof discharges rainwater directly to the base of the building.<br/>Discharging water from a downpipe at the base of a building can cause several problems. It can lead to soil erosion, penetrating dampness, water damage, and impact the stability of the buildings footings/structure. Directing the downpipe away from the building and discharging the water onto a permeable surface or into a drainage system can help avoid these issues.</p> <p>The soil stack and associated plumbing is in a fair condition with no leakages noted.</p> | | |

Staining observed beneath front gutter

| <b>Action<br/>Required</b> | <p>Gutters and downpipes should be cleaned and inspected regularly to ensure that they are free from blockages and leaks. If it is noted during any heavy rain, that gutters or downpipe joints are leaking, then these must be fixed as soon as possible to prevent water penetration to the property and damage to the foundations.</p> <p>Install gutter guards or leaf traps where appropriate to reduce future moss and debris accumulation. Monitor affected walls internally for any signs of moisture ingress that may have resulted from prior gutter overflows.</p> | | |

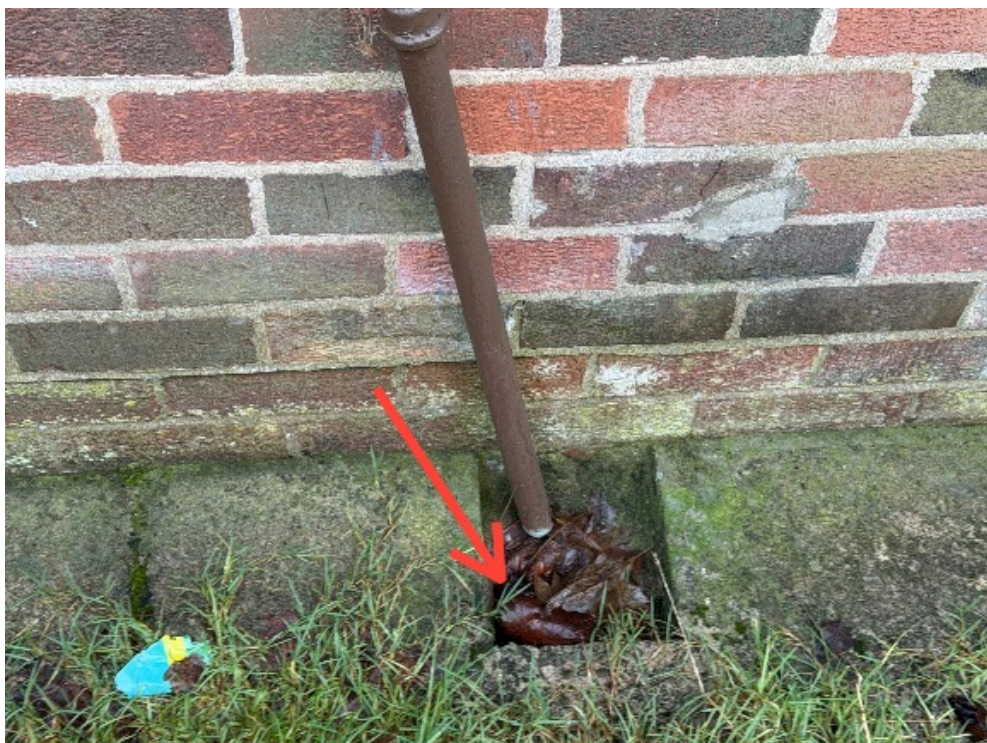
Detritus in gully

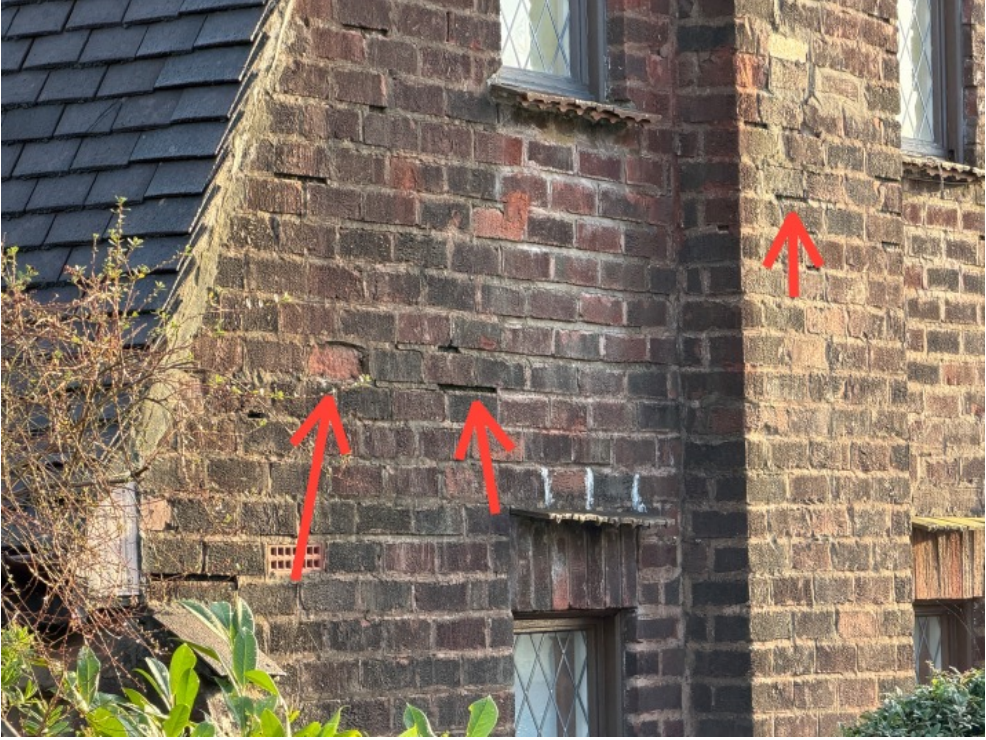
| | <p>Spalling brickwork and missing mortar pointing - right side elevation</p> |

| <b>Action Required</b> | <p>Repairs are needed to the right side elevation wall including replacing missing areas of mortar. Replace any severely spalled bricks with matching materials to maintain structural and aesthetic integrity.</p> <p>Monitor for further signs of moisture ingress internally and ensure adequate ventilation and heating to help control condensation internally.</p> <p>Walls should be examined regularly to inspect for changes in the nature of any cracking or other defects that may become apparent.</p> <p>You should carry out a thorough visual inspection at least once a year, ideally in the Spring to identify and repair any damage that could have been caused by winter weather.</p> <p>Ensure that the air bricks, visible at the base of the external walls, are kept clear to maintain adequate ventilation in the underfloor void. External paving and soil levels should not be allowed to rise above the level of the air bricks.</p> |

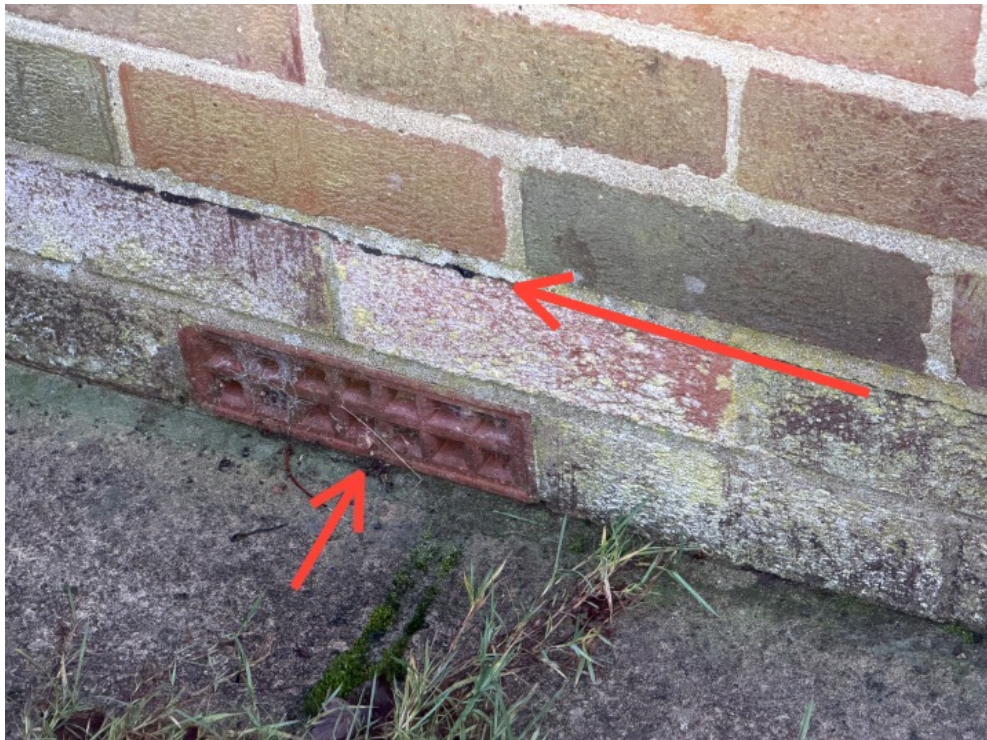
Subfloor ventilation points and dpc line - air brick in close proximity to ground level

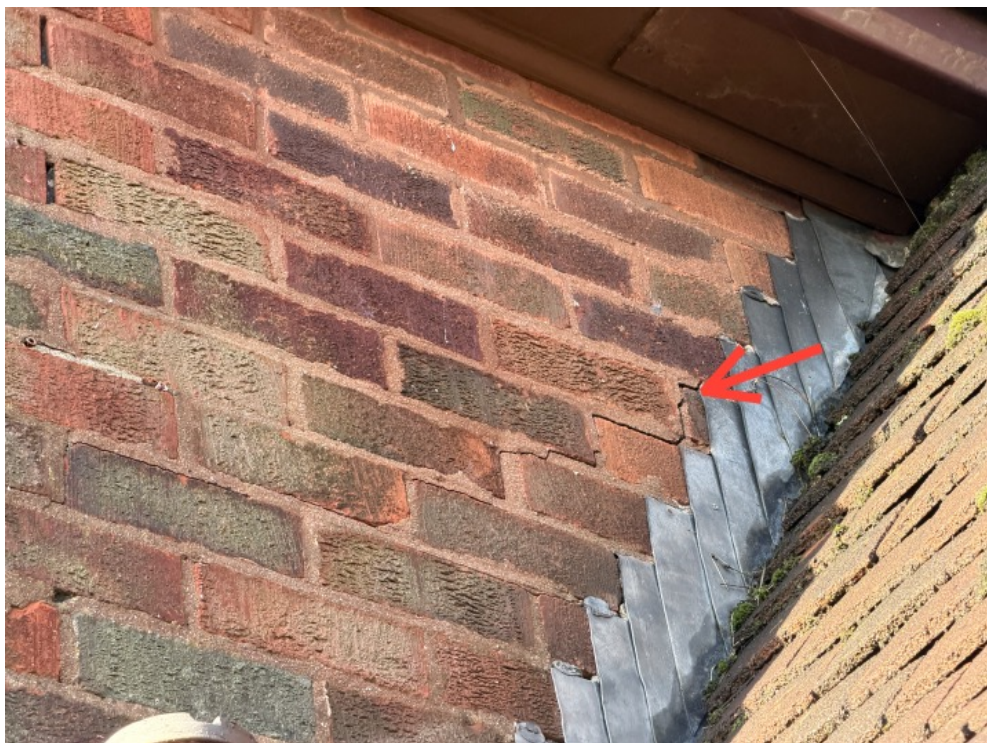
Hairline cracking to mortar joints

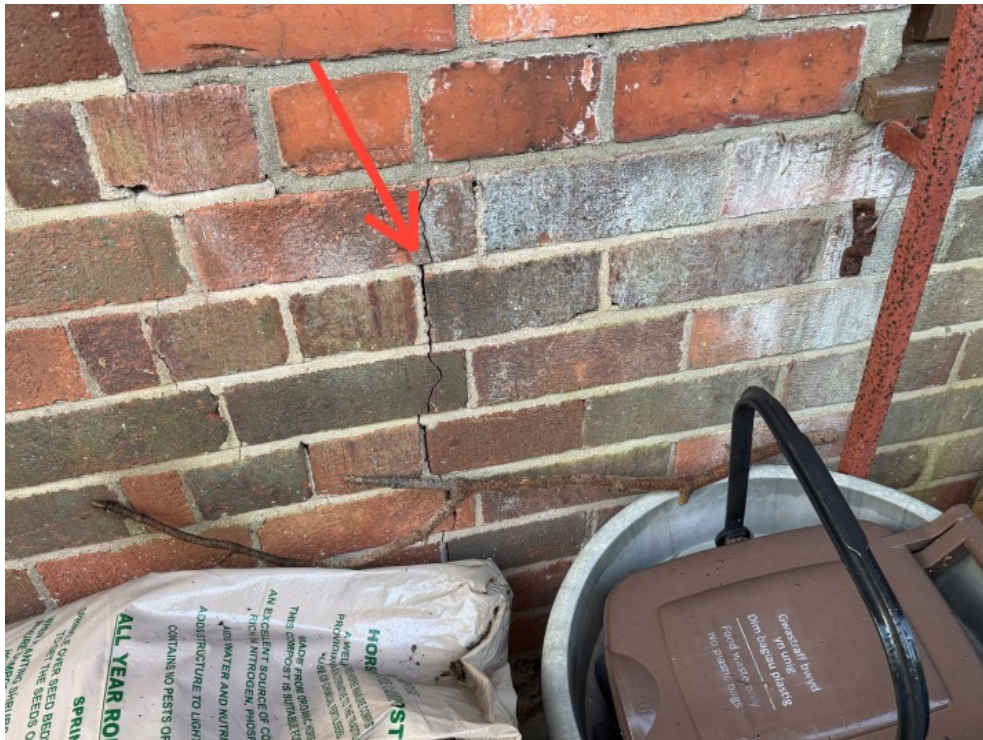
Fractured section of brickwork left side elevation

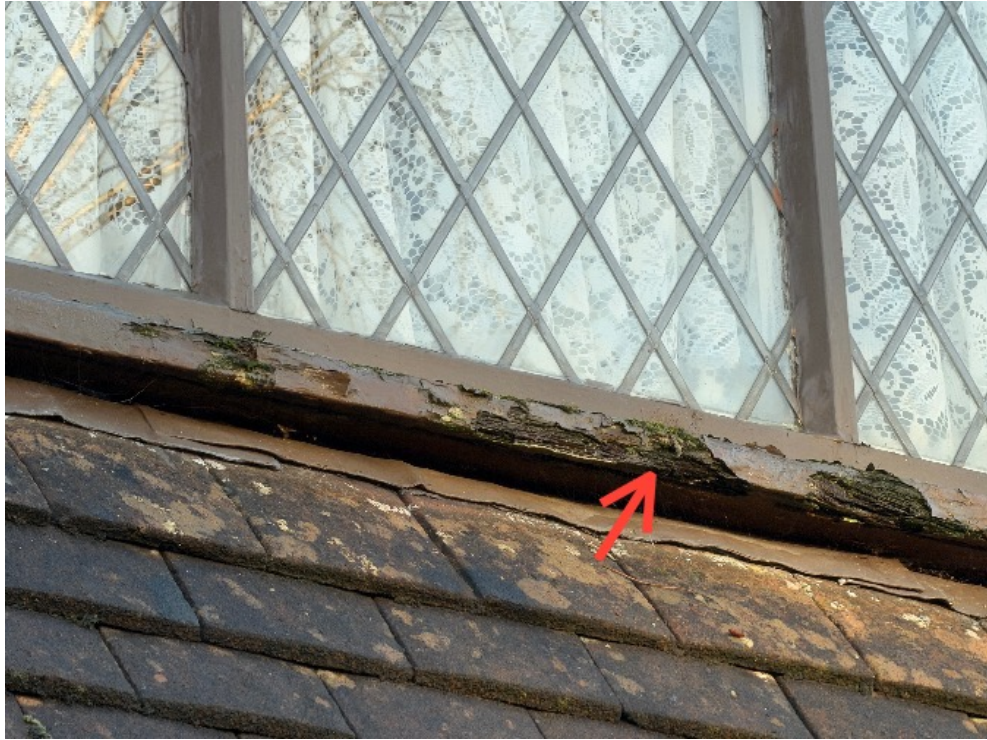
| <b>Condition</b> | <p><b>Doors</b></p> <p>The external door to the left side utility room was found to be locked at the time of inspection, and no key was available. As a result, the door could not be tested for operation, condition, or security.</p> <p>The rear timber French doors serving the lounge were found to be in poor condition, with clear evidence of decay and softening to the lower sections of the door leaves and frame. Paintwork was found to be peeling and worn, exposing the timber beneath to prolonged moisture ingress.</p> <p><b>Windows</b></p> <p>Most timber window frames and cills including dormer windows were found to be in poor condition, with clear evidence of decay and softening and frame. Paintwork was found to be peeling and worn, exposing the timber beneath to prolonged moisture ingress.</p> <p>The metal window frames were found to be displaying advanced signs of corrosion. This includes flaking paint, surface rust, and pitting. Structural weakening of frame sections, which impairs the integrity of window operation or compromise security.</p> | | |

Decaying timber dormer window cill

| <b>Action<br/>Required</b> | <p>The defects noted have arisen due to the age of the existing windows, prolonged exposure to the elements, and a lack of consistent maintenance. Single-glazed units offer minimal thermal insulation, and damaged frames often allow for moisture ingress and air leakage, accelerating their decline.</p> <p>It is recommended that the affected windows be fully replaced with modern uPVC double-glazed units, which provide significantly improved thermal performance, weather resistance, and security.</p> <p>Be aware that previous owners may have distributed multiple sets of keys for the windows and doors to individuals not known to you. When purchasing a property, you should consider the cost of replacing all of the door and window locks as soon as possible after you take up occupation. When doing this you should consult your insurers to ensure that you meet their requirements for security, and obtain any discounts that may be available by improving the security of the property.</p> | | |

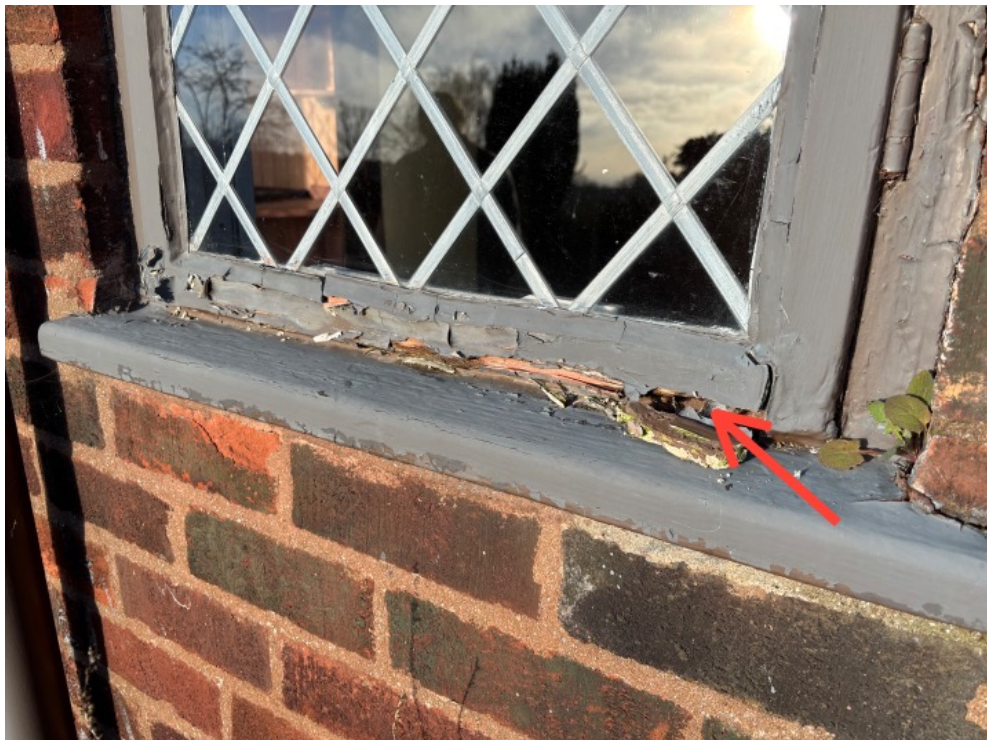
Decaying timber window frame

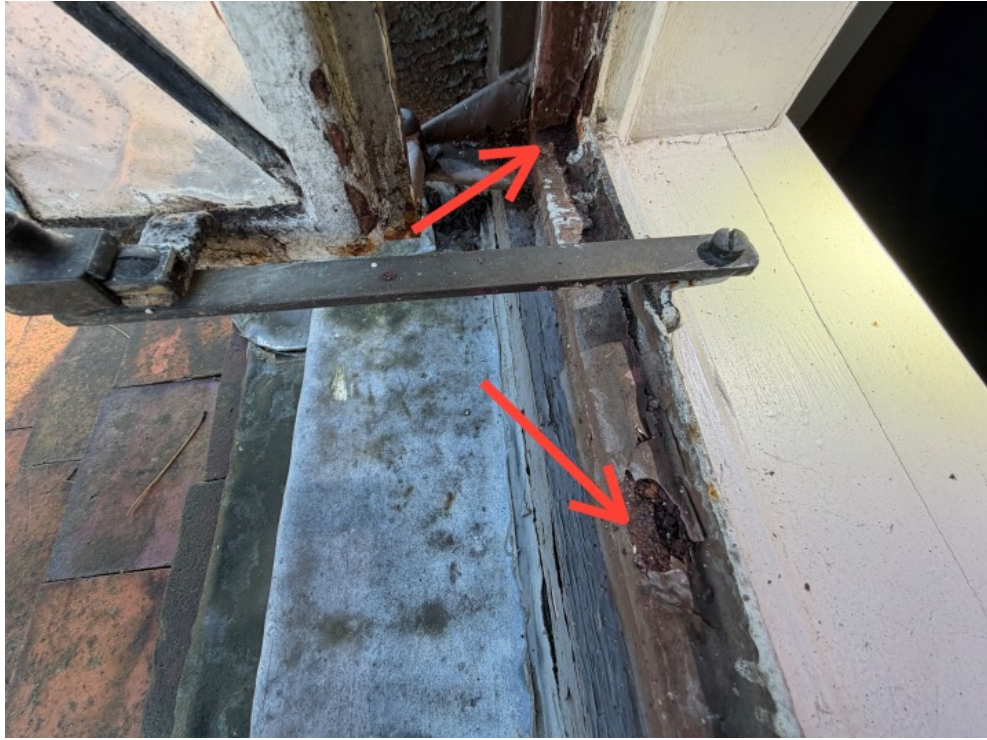
Corrosion to metal window frame

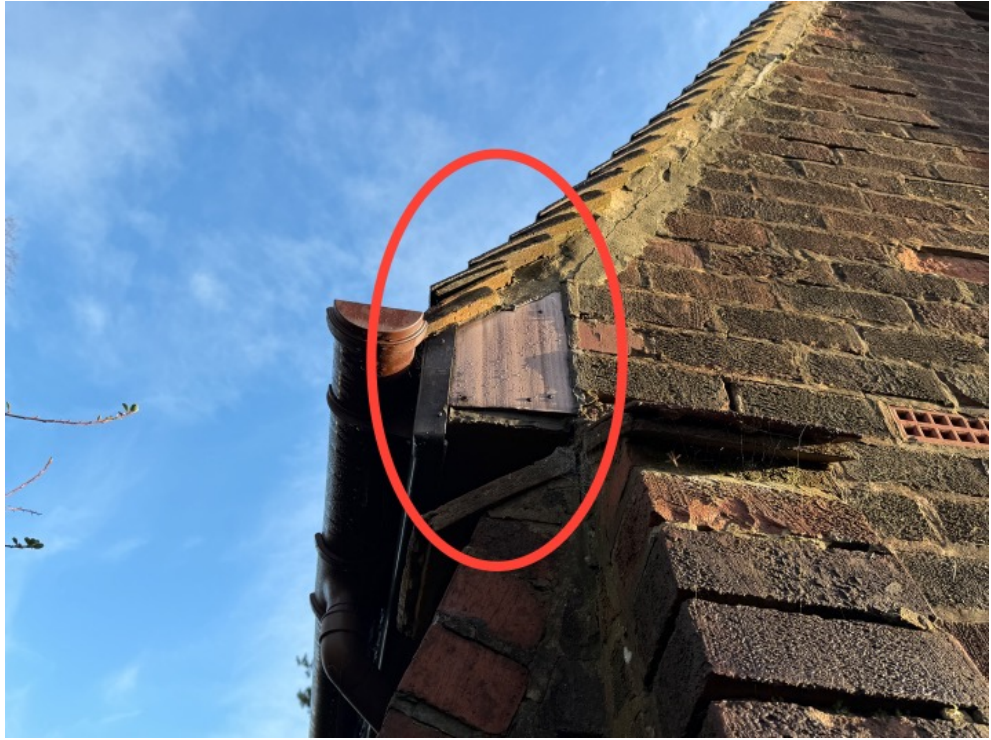
| <b>Condition</b> | <p>Most of these timbers are visibly sound, have been maintained and are in a serviceable condition.</p> <p>A section of PVC end cap is missing from the front right fascia and soffit board. This leaves the edge of the timber substructure exposed to external weather conditions.</p> | | |

Missing end cap to right side external joinery

| <b>Action<br/>Required</b> | <p>Regular maintenance will be required especially to the right side elevation which faces south-west. This section of the property will receive most of any inclement weather and the heat of the sun.</p> <p>Fascia boards are an important component of a house's exterior as they protect the eaves and rafters from water damage. They also provide a finished appearance to the roofline. If fascia boards are not properly maintained, water can seep into the eaves and rafters causing rot and structural damage. Additionally, if the fascia is not in good condition, it can negatively impact the overall aesthetic of the house. It's important to maintain fascia boards by inspecting them regularly for signs of damage and making repairs as necessary.</p> | | |

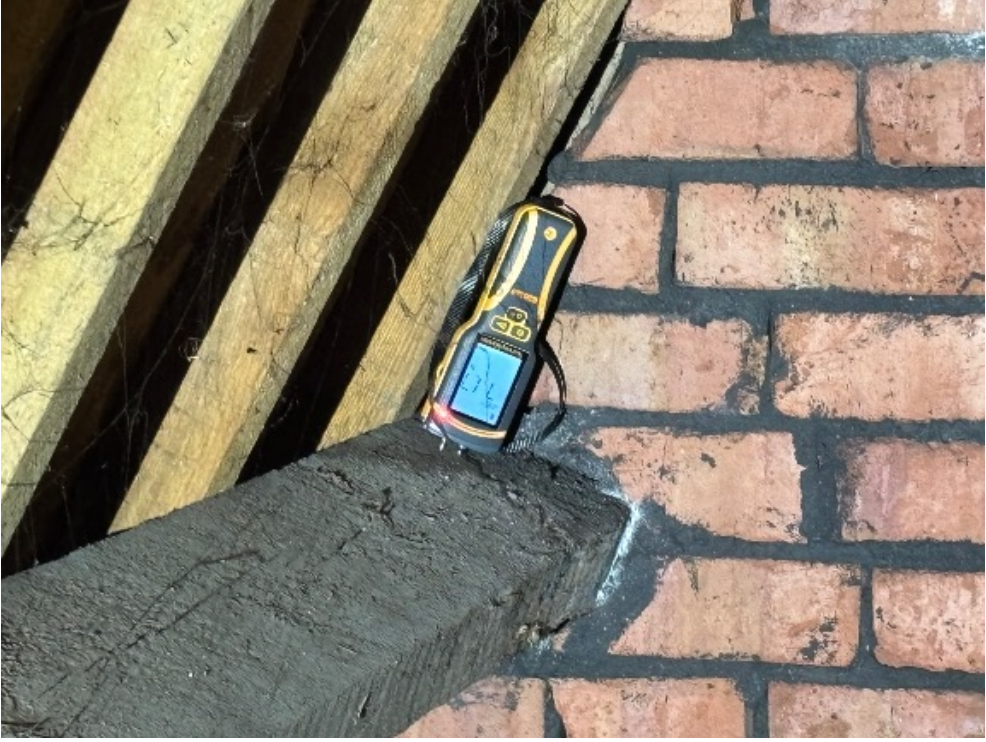
| <p><b>Condition</b></p> | <p>Brown staining was observed to the purlin timber where it is embedded into the right side elevation wall within the main roof void. Moisture meter readings taken at this location exceed acceptable limits, indicating ongoing dampness within or around the embedded end of the structural timber.</p> <p>The staining and moisture ingress are caused by water penetration through the external wall or associated roof elements, such as defective flashings, cracked mortar joints, or porous masonry. As the timber is embedded into the solid wall, any water tracking through the masonry can be absorbed by the timber end, particularly if the wall is saturated or unsealed externally.</p> <p>Brown staining and visible water penetration were observed on the underside of the sarking felt to the side roof slope. The ingress is actively saturating the structural roof timbers, including rafters and potentially the purlin and wall plate in this location. This is indicative of ongoing roof failure in the affected area.</p> <p>The defect is likely due to damaged or displaced roof coverings defective flashing, or the lack of sufficient slope required for a tiled roof, allowing water to pass through the roof tiles and membrane. Once the membrane has failed, water is able to track underneath and reach the timbers below.</p> <p>The slope is shallow and may not provide adequate water run-off during periods of rainfall.</p> <p>High relative humidity levels can lead to condensation build up and effect moisture content within timbers leading to a number of defects. It is important the roof void is well ventilated. In this case, humidity levels were recorded at 86% (high).</p> <p>The installation of felt lap vents and tile vents is recommended to effectively ventilate the roof void.</p> <p>The main roof space is laid with about 100mm of wool type insulation at joist level. Increasing the thickness to the current recommendation of 270mm is recommended for increased energy efficiency, but when adding insulation it is important to maintain good ventilation within the roof space and not to block ventilation grillws or openings.</p> <p>Between the outer tile covering and the inner timbers is an underlining, sometimes called "sarking". It is present to provide an additional weather-proofing layer to moisture, snow and rain etc. that may be blown past the outer covering. In older properties it may not be present at all. Typically, in the 1920's the sarking is of timber planks. Later properties often have a layer of bituminised felt, while in modern properties a breathable membrane, such as Tyvek, is normally used. In this case the sarking is of bitumen. It was found to be in a mostly undamaged condition but has areas of tears that will require patch repair.</p> |

| | <p>High moisture recorded in purlin to right side elevation</p> |

| <p><b>Action Required</b></p> | <p>Regularly monitor timbers, at least twice a year, for evidence of wood boring insects and other such infestations.</p> <p>It is not possible to inspect each individual timber in a general building survey. It is recommended you instruct a timber and damp specialist to further inspect timbers in the property for rot, decay, and wood boring insect infestations.</p> <p>It is important to ensure that spaces remain well ventilated so as to reduce the likelihood of the development of defects such as rot and infestations by wood boring insects. In many cases, ventilation derives from openings at the eaves at the edge of the roof, though these can become blocked where insulation is forced into the spaces. When adding or replacing insulation, make sure that good ventilation is maintained.</p> <p>If installing extractor fans, make sure that hoses passing through the roof space extend to an external grille so that warm moist air is not ventilated into the roof.</p> <p>Care should be taken when moving around, or storing heavy objects, in the roof space. The spaces between the floor joists will not support a persons weight, or that of large boxes etc. Where heavy items are to be stored it is important to distribute the weight evenly using fixed boards. Additional structural support may be required if you plan to store large quantities of heavy items in the roof space.</p> |

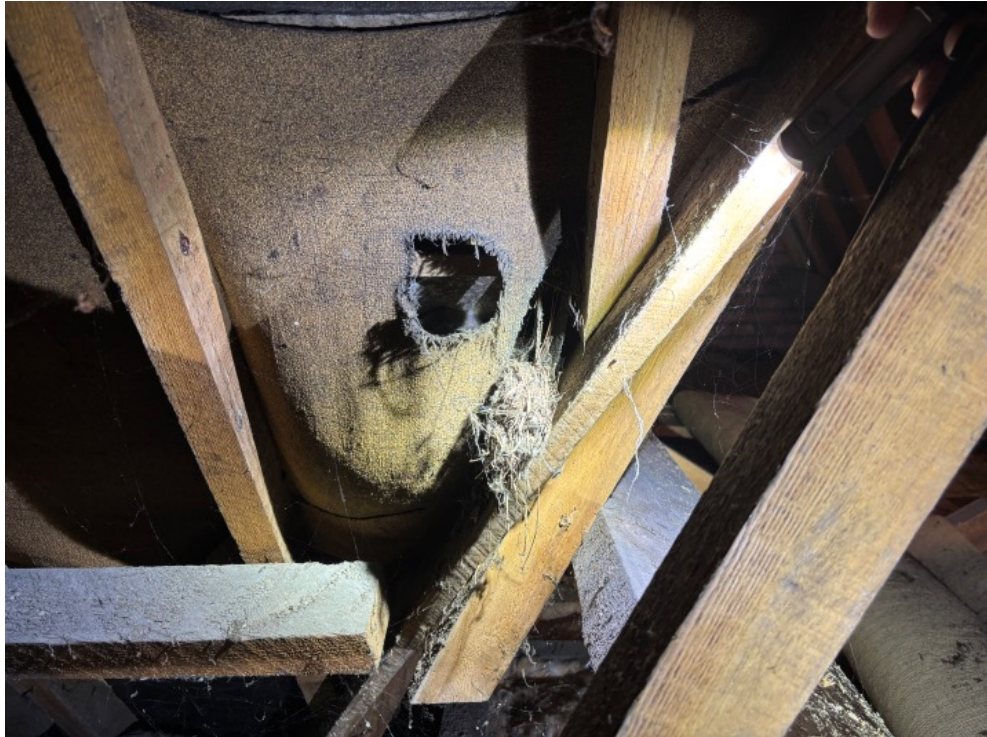
Evidence of nest behind roofing felt

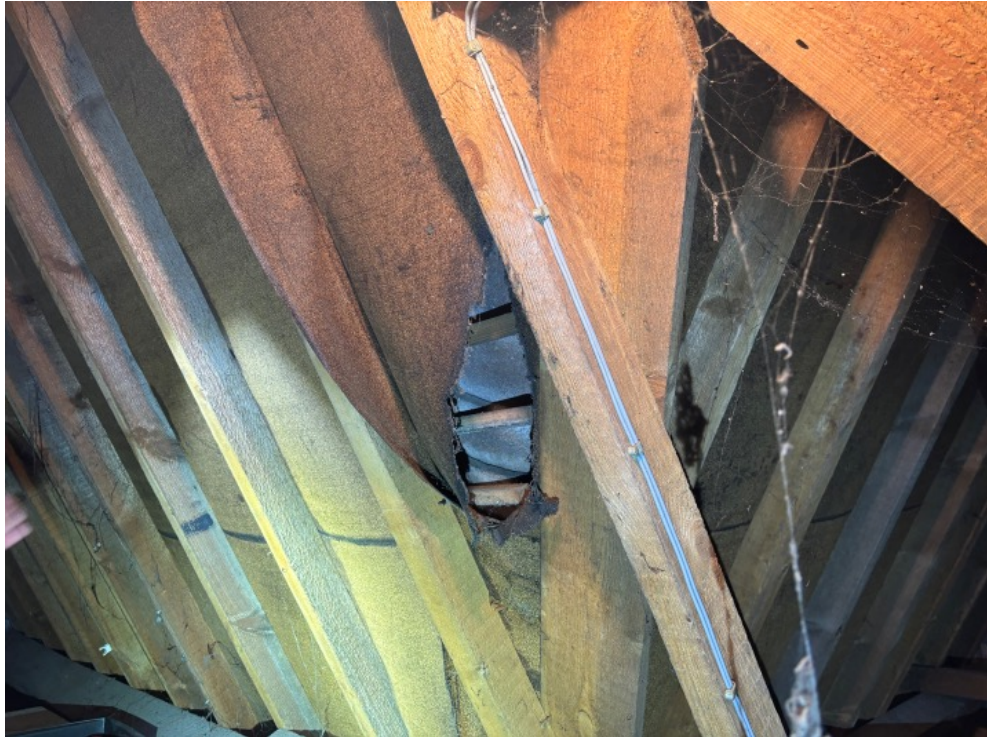
Torn roofing felt

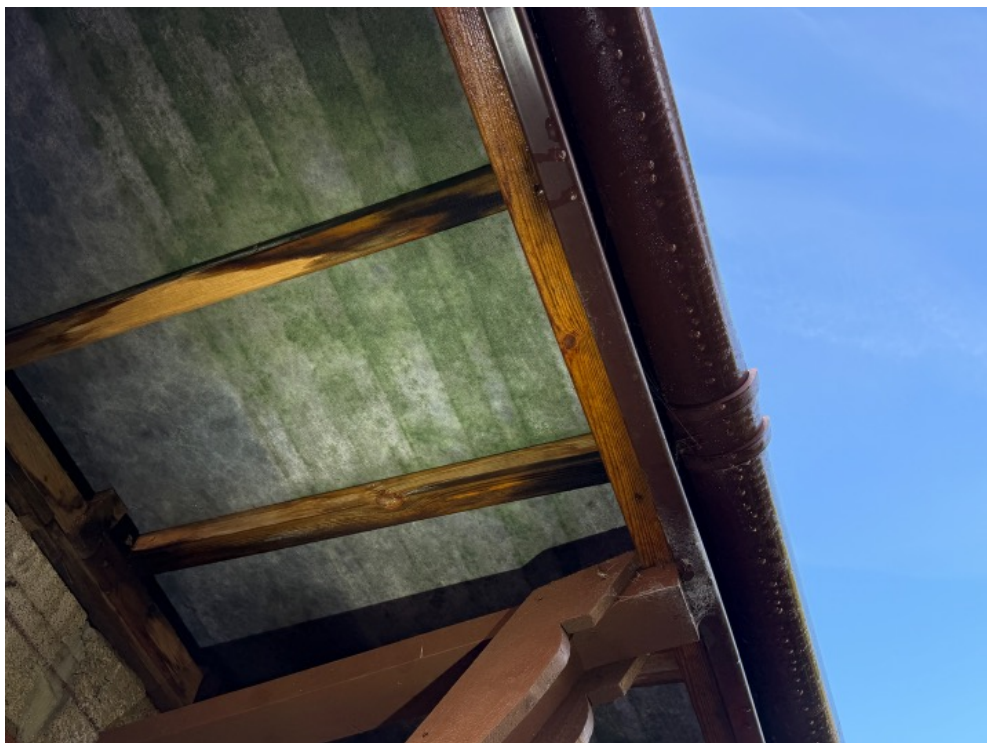
Water stained felt and roof timbers
