# BUILDING SURVEY REPORT

**PROPERTY** 28 Example Street  
Sample  
UK  
EX1 2EX

**SURVEY DATE** 01/01/2027

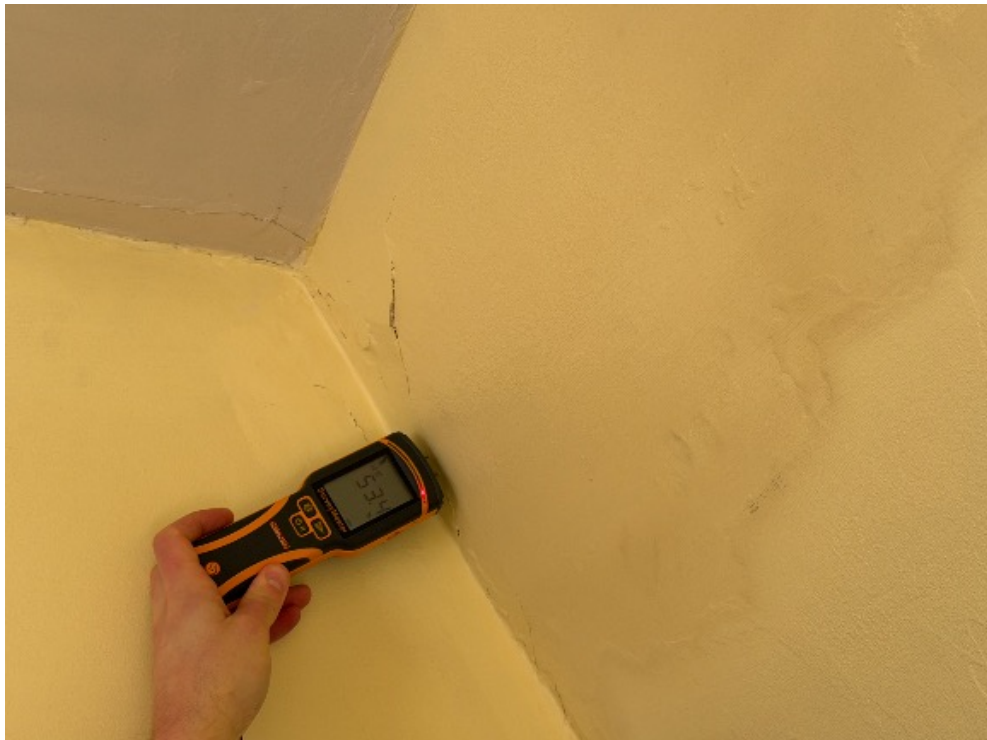
Dampness noted to ceiling in bedroom 1

| <b>Action<br/>Required</b> | <p>Normal future maintenance is required, including filling and redecorating any cracks as necessary.</p> <p>Where high moisture levels persist, remove affected ceiling finishes locally to allow full drying and assessment of concealed timber condition.</p> | | |

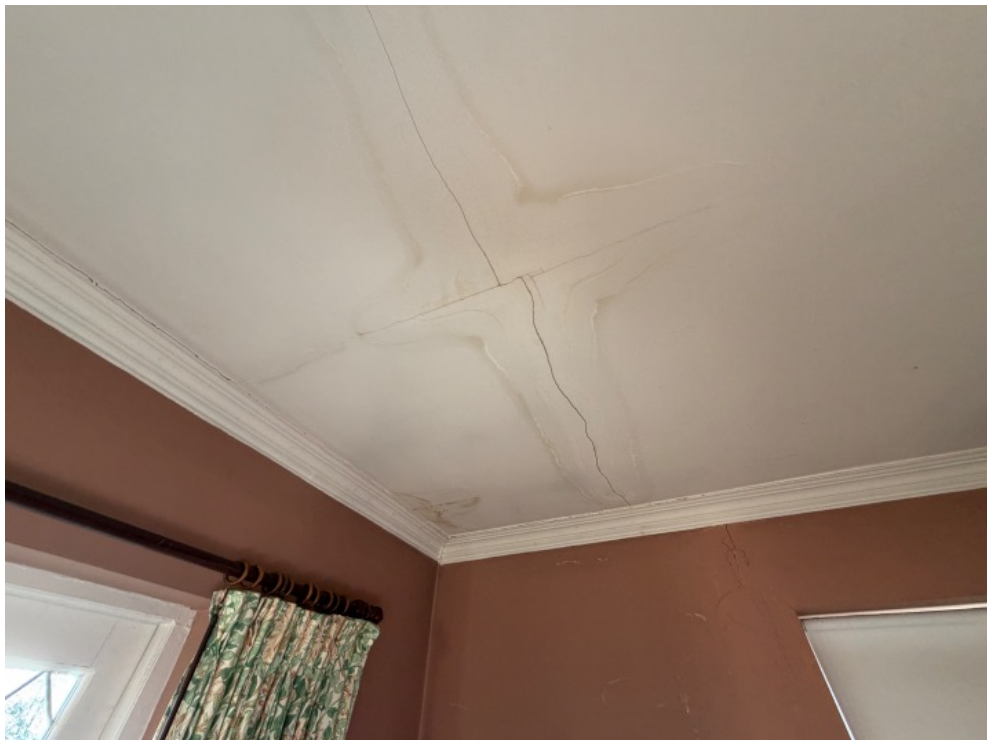
Moisture damaged ceiling - living room

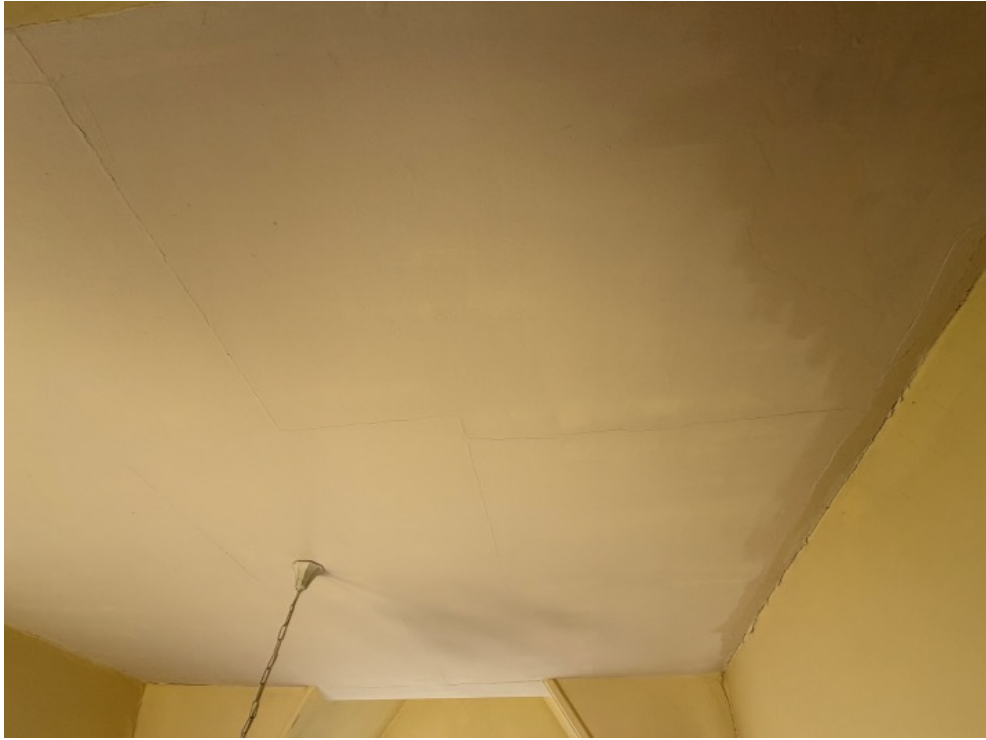
Hairline cracking to plasterboard junctions

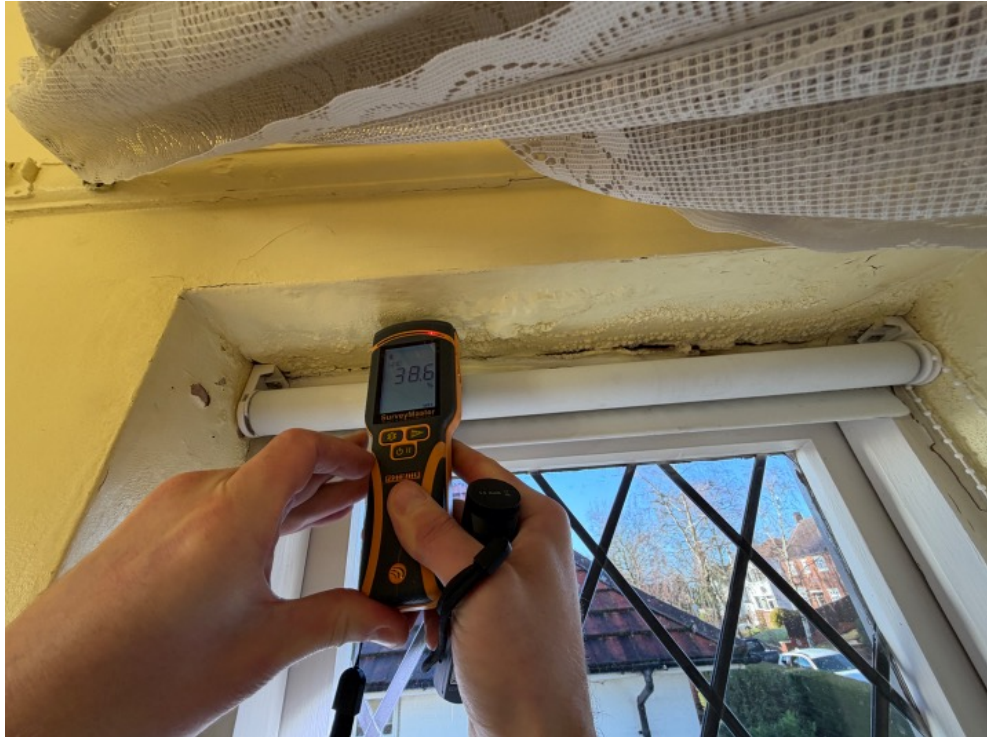
Dampness noted to bedroom 1 walls

| <p><b>Action Required</b></p> | <p>A thorough inspection of the external roof elements, chimney stacks, flashings, and associated junctions is required to identify and rectify sources of water ingress.</p> <p>A structural engineer should be appointed to assess the adequacy of the RSJ support and bearing.</p> <p>Invasive investigation may be required to expose the bearing ends and confirm whether the RSJ is correctly seated into the wall with appropriate padstones and minimum bearing lengths (typically 300mm, depending on the load and design).</p> <p>Allow walls to dry thoroughly before carrying out plaster and decoration repairs.</p> |

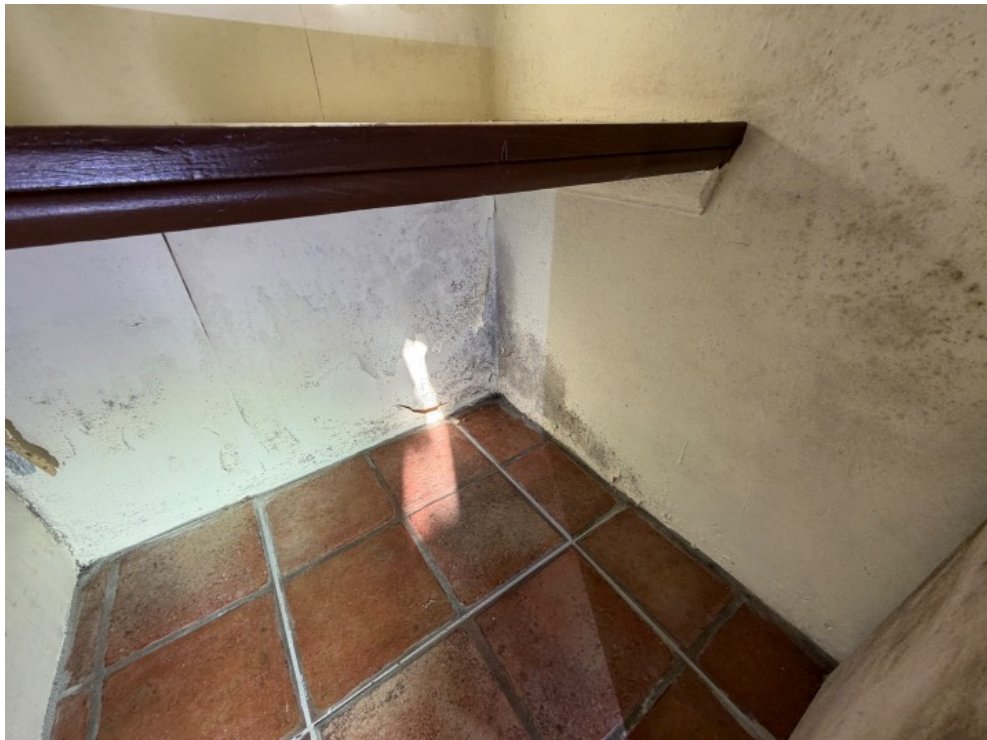
Black mould evidence in kitchen cupboard

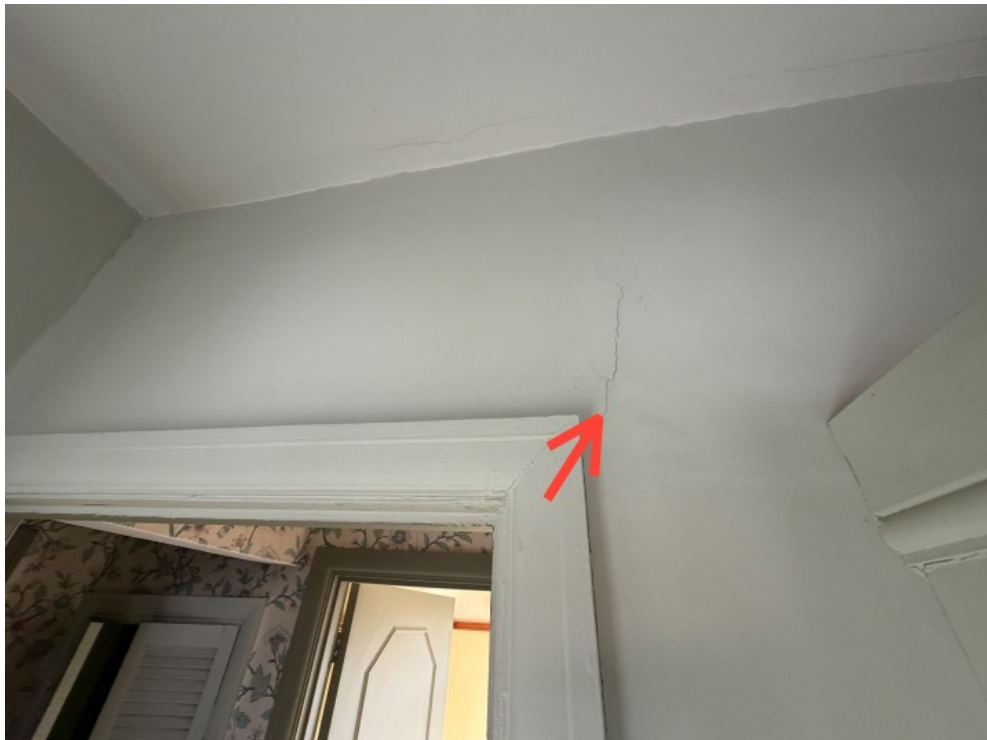
Hairline cracking above bedroom door

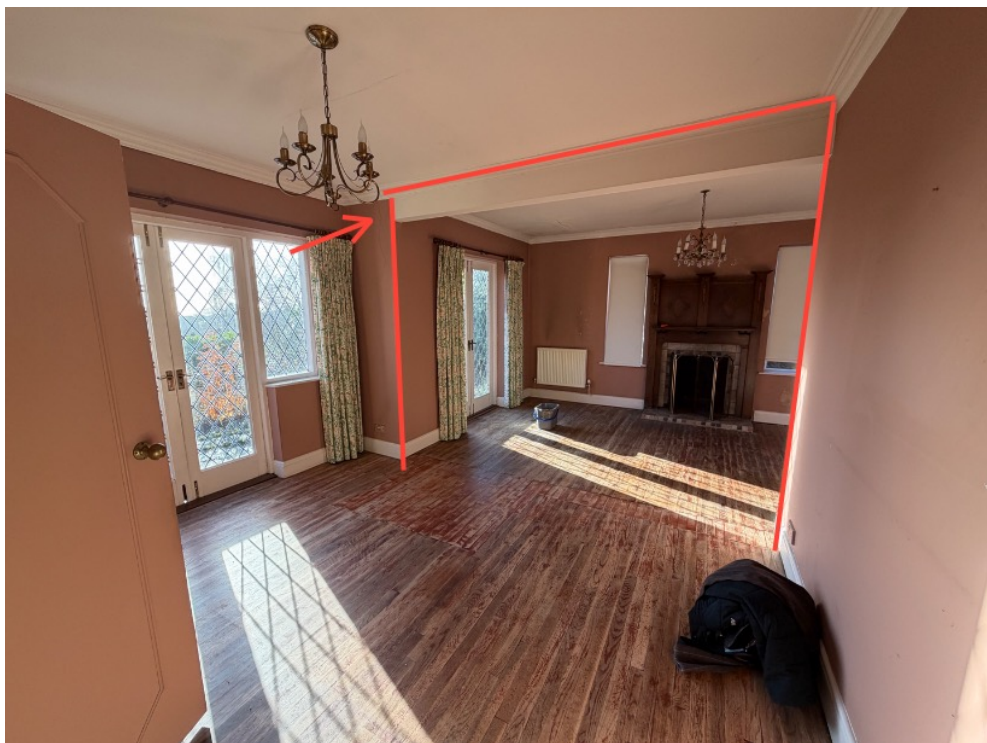
Wall removal from lounge - fracture in plaster

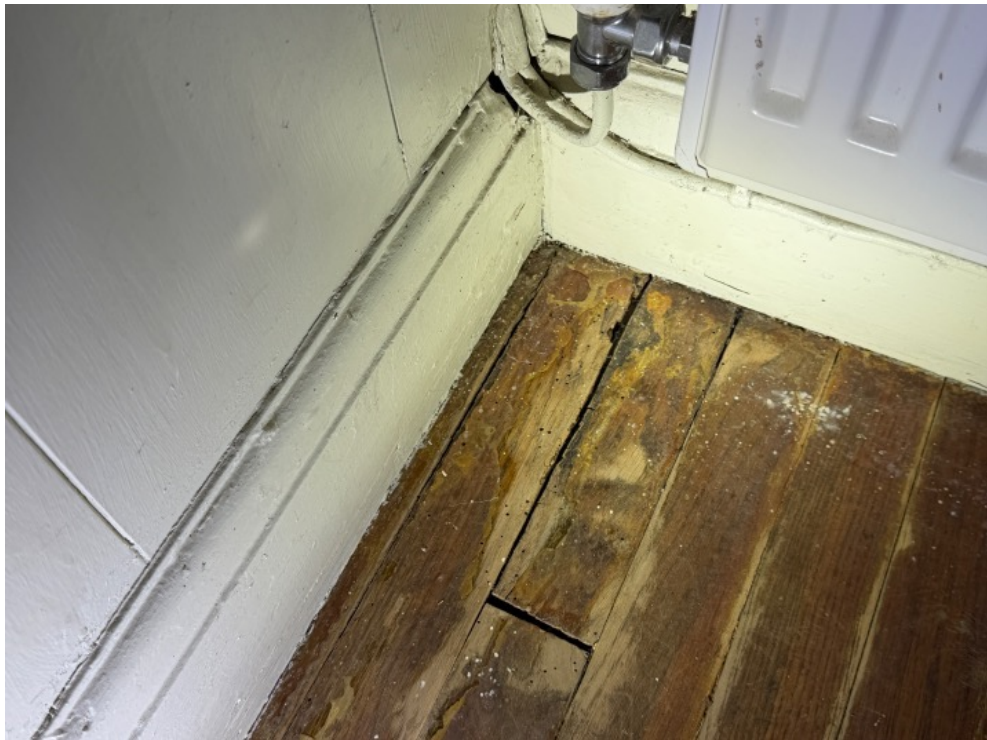
Moisture damaged and woodworm evidence to flooring in entrance hall beneath radiator valves

| <p><b>Action Required</b></p> | <p>Ensure that the air bricks, visible at the base of the external walls, are kept clear to maintain adequate ventilation in the underfloor void. External paving and soil levels should not be allowed to rise above the level of the air bricks.<br/>A lack of ventilation can allow moisture levels beneath the floor to become elevated, increasing the risk of the development of moisture related defects such as rot and infestations by wood boring insects (commonly known as woodworm).</p> <p>It is recommended you instruct a timber and damp specialist to further inspect floors and floor timbers by undertaking an invasive survey by removing floor coverings.<br/>Floors should be monitored for any changes that occur in their level or springiness or noise, and further investigations carried out should any such changes become apparent.</p> |

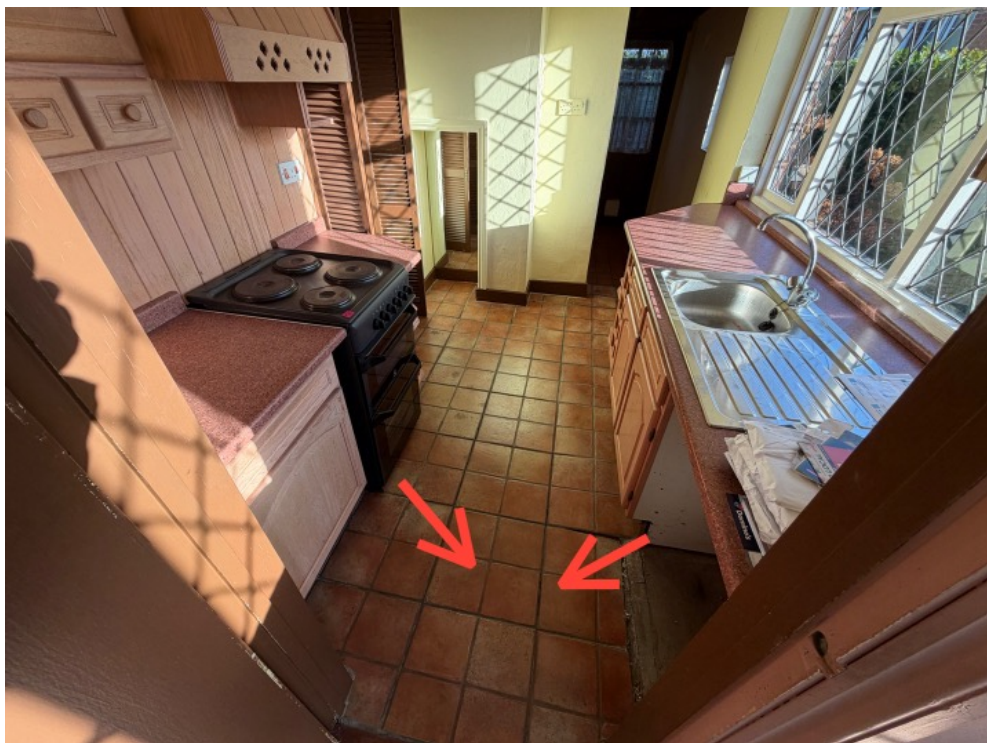
Uneven floor in kitchen

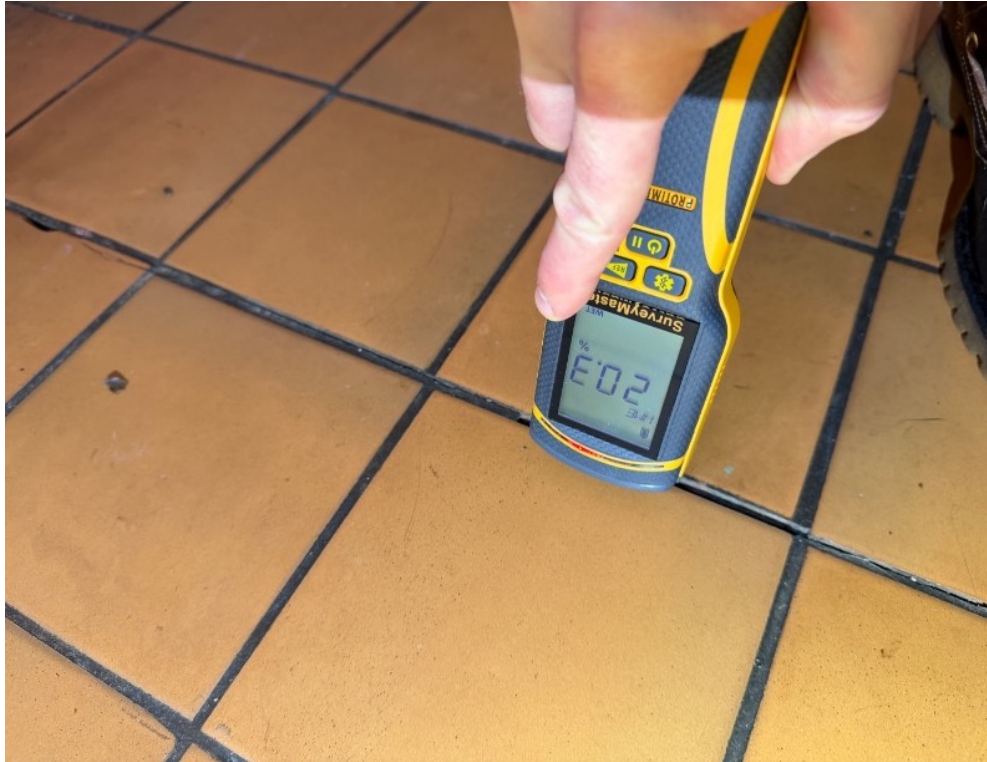
Moisture detected in utility room solid floor

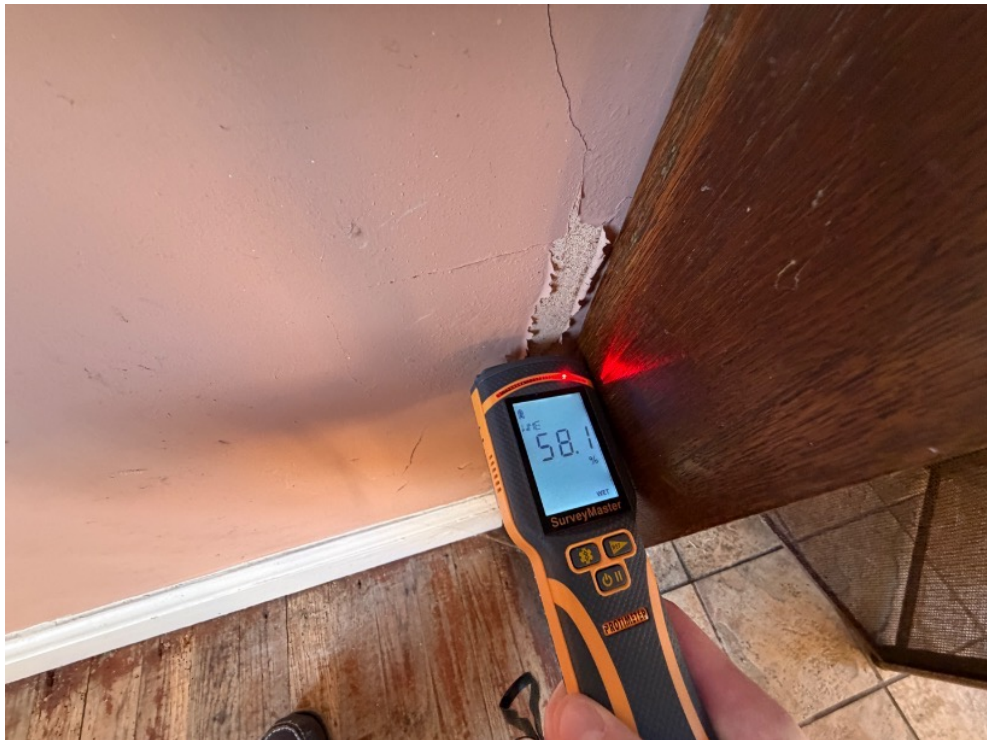
High moisture recorded in wall next to fireplace

| <b>Action<br/>Required</b> | <p>All active flues should be checked by a reputable heating engineer specialising in flues and chimneys, prior to use. Flues should also be swept clean at this time.</p> <p>Maintain consistent background heating and improve ventilation in the affected areas. It is important to maintain an adequate airflow, by means of ventilation, through unused chimney flues to prevent the build-up of condensation within the chimney. Ventilation grilles should be fitted to all blocked breasts.</p> | | |

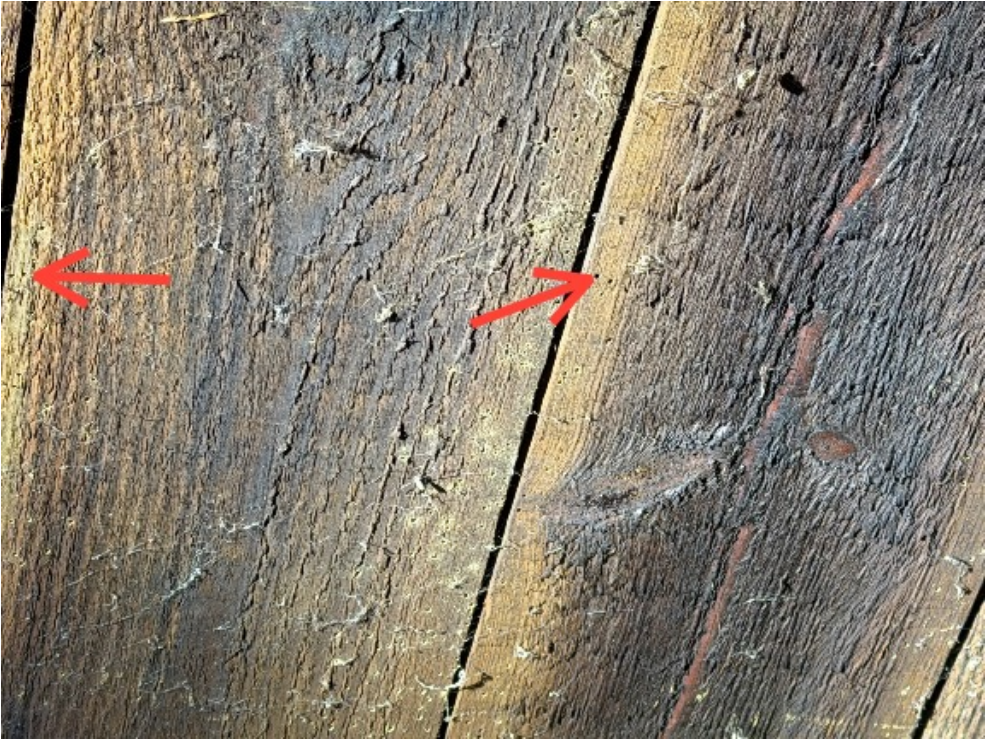
| | <p>Wood boring beetle flight holes</p> |

| <p><b>Action Required</b></p> | <p>A specialist timber and damp survey should be commissioned immediately to confirm the type and extent of rot, identify affected areas, and propose a suitable treatment plan.</p> <p>Possible solutions may include:</p> <ul style="list-style-type: none"> <li>• Installation of a surface-applied damp proofing system or retrofit damp proof membrane;</li> <li>• Use of breathable floor finishes and wall plasters;</li> <li>• Improved ventilation and heating to help manage condensation and aid drying;</li> <li>• Affected timbers should be repaired or replaced once the source of moisture is managed;</li> <li>• Monitor moisture levels periodically to confirm effectiveness of remedial actions.</li> </ul> <p>Roof and chimney coverings should be repaired or replaced without delay to eliminate the source of water ingress;</p> |

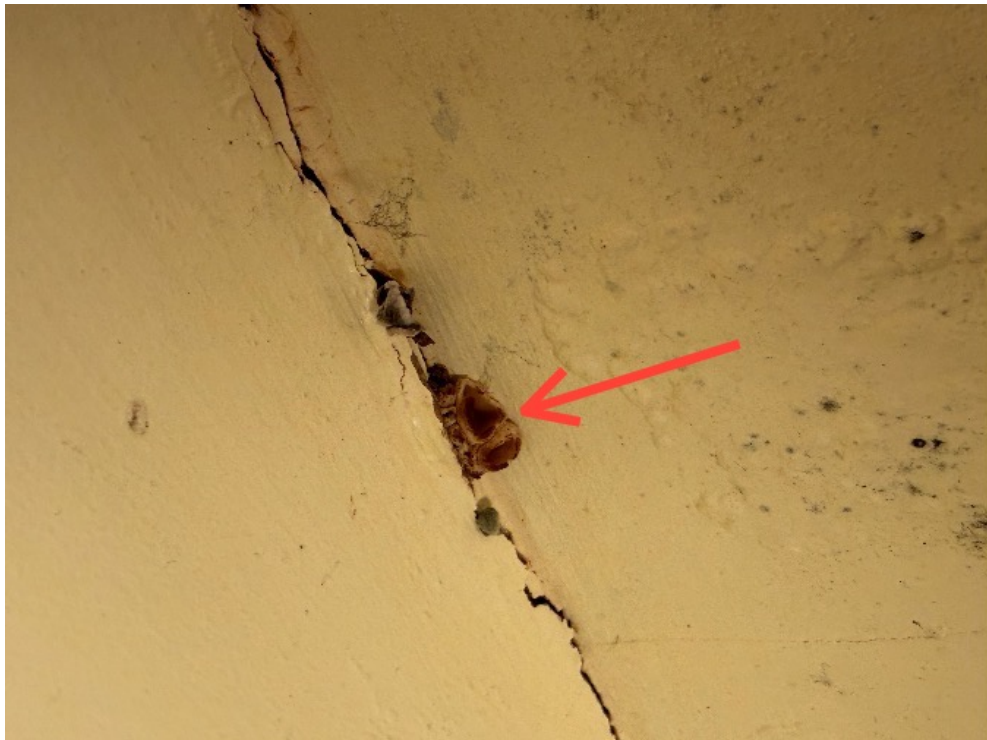
Fungal growth in bedroom 1

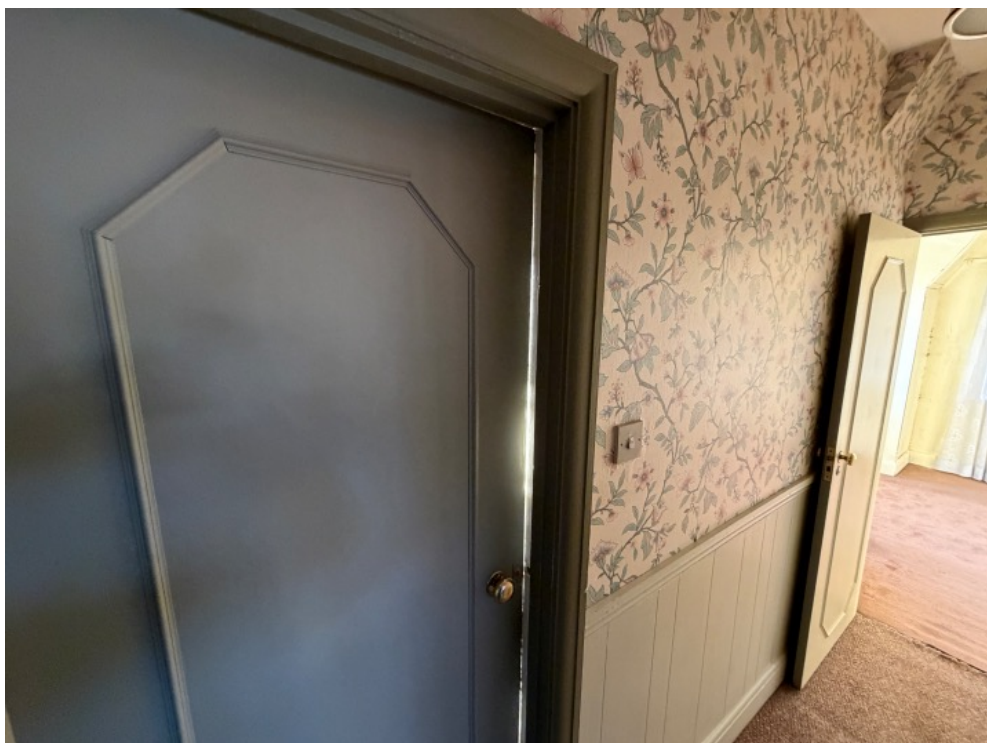
Bathroom door fouling in frame

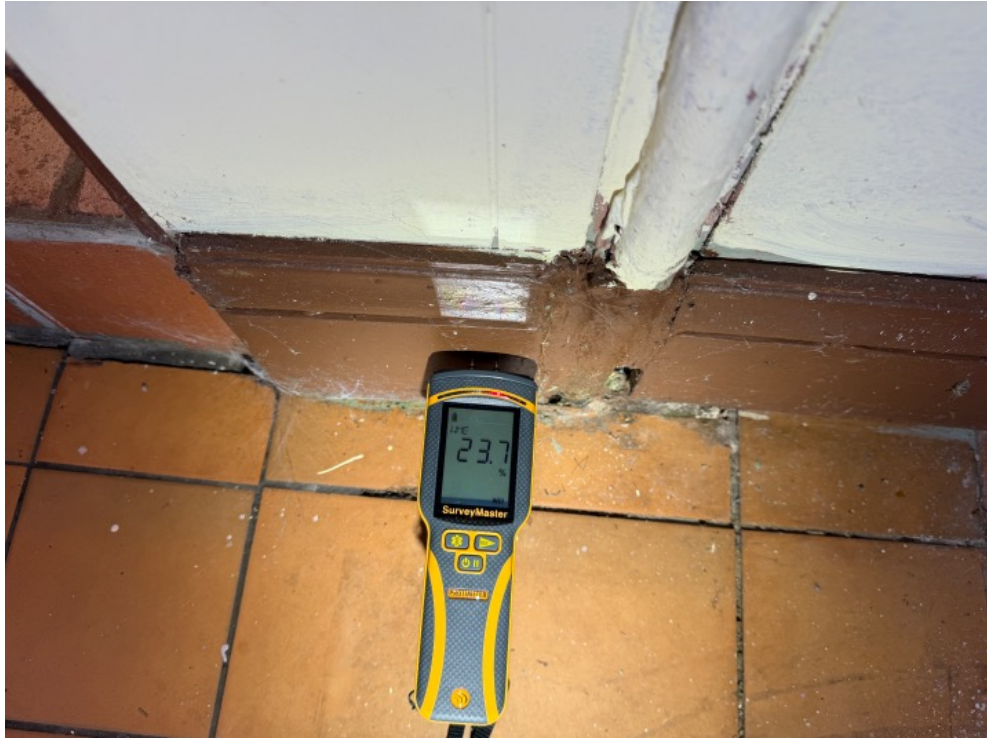
High moisture in utility room skirting boards

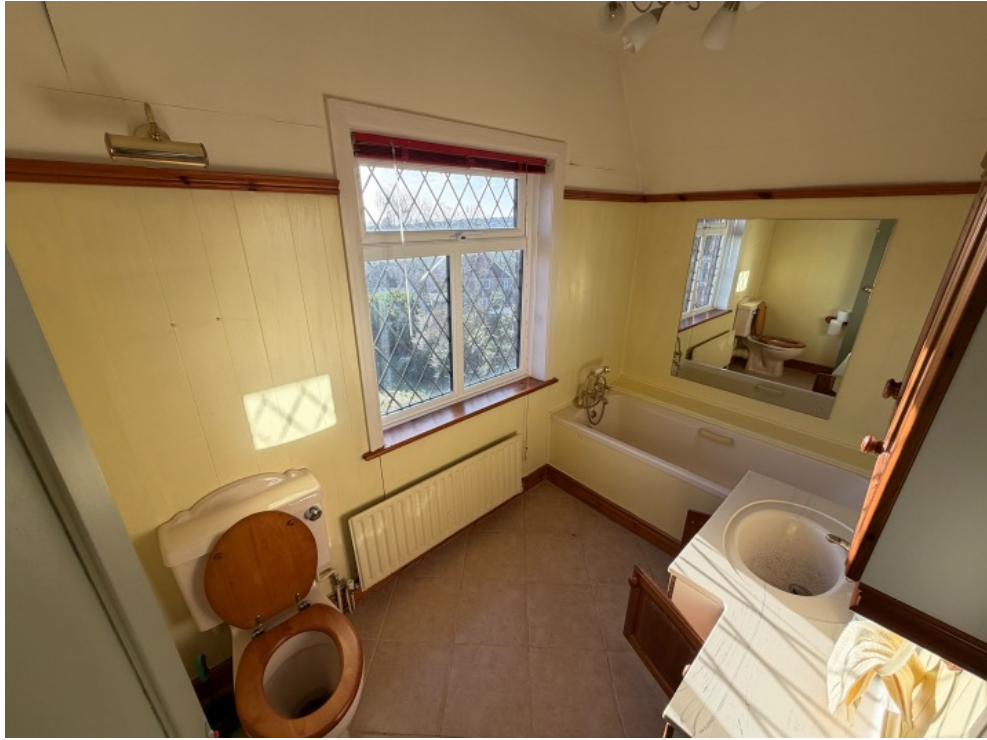
Lack of mechanical ventilation to bathroom

| <b>Action<br/>Required</b> | <p>Maintain, repair or replace units as necessary.</p> <p>It is strongly advisable to install an extraction fan to improve ventilation.<br/>Regular maintenance of all seals to the bath and shower to prevent water displacement.</p> <p>It is recommended that the existing light fitting be replaced with an appropriately IP-rated unit suitable for use in bathrooms. A qualified electrician should carry out the replacement to ensure compliance with current regulations.</p> | | |

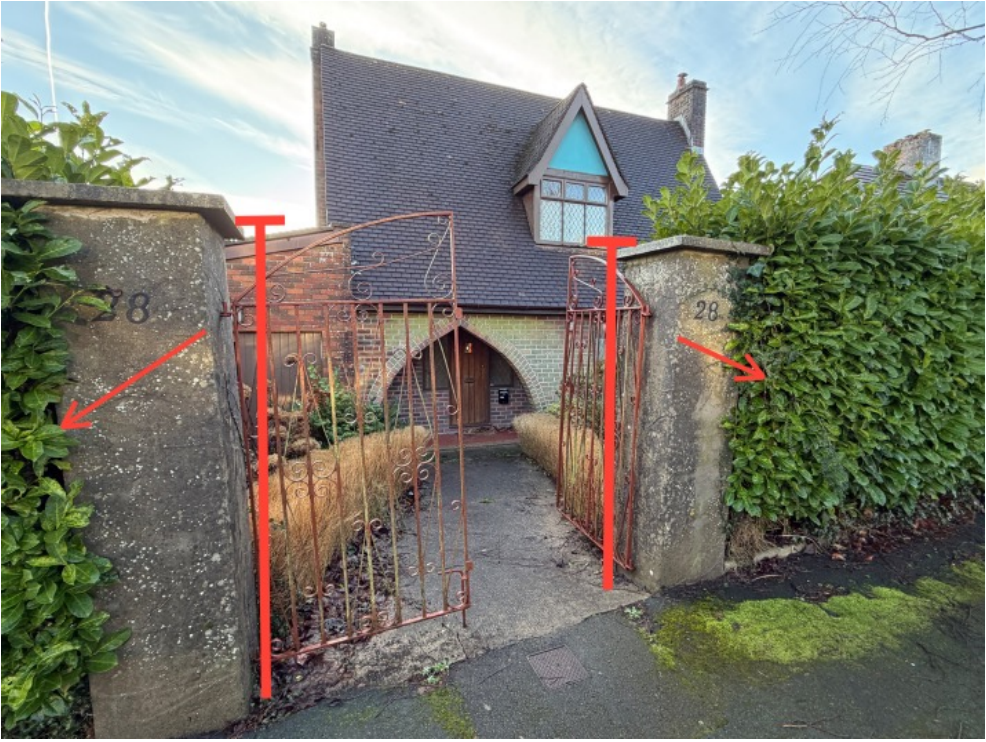
| | <p>Listing gate pillars</p> |

| <p><b>Action Required</b></p> | <p>It is recommended that loose and damaged slabs be lifted and relaid or replaced as necessary to provide a level and stable surface. Vegetation should be removed, and appropriate measures taken to prevent regrowth. Regular maintenance of the patio area is advised to reduce the risk of further deterioration and safety hazards.</p> <p>The shrubs should be regularly pruned and maintained to prevent excessive growth and to ensure adequate clearance from the building fabric. Ongoing grounds maintenance should be anticipated as part of ownership to manage future risks and preserve the condition of the property.</p> <p>It is strongly recommended that a suitable safety railing or guarding be installed to the patio edge to reduce the risk of falls. The design and installation should comply with current Building Regulations and relevant safety standards. This matter should be addressed as a priority.</p> <p>Consideration should be given to repairing or replacing affected timber panel fencing as necessary. All timber fencing should be treated with a suitable preservative to improve durability and prolong service life. Ongoing maintenance should be anticipated to prevent further decay.</p> <p>It is recommended that the pillars be inspected more closely to determine the cause of movement. Remedial works may include realigning, stabilising, or rebuilding the pillars and ensuring foundations are sound. Regular monitoring is advised to assess if further movement occurs.</p> |
