# BUILDING SURVEY REPORT

**PROPERTY** 28 Example Street  
Sample  
UK  
EX1 2EX

**SURVEY DATE** 01/01/2027

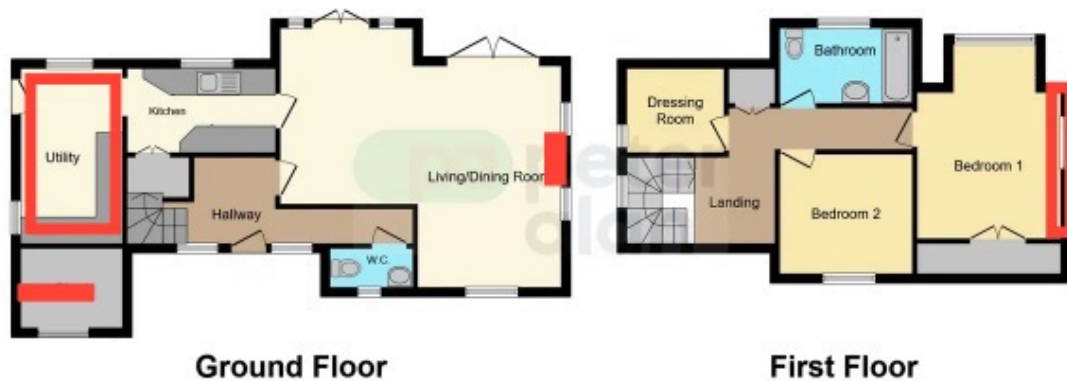
Floorplan

Areas highlighted in red on the plan indicate where high moisture meter readings were recorded, indicating that dampness may be present. Dampness may be present in locations not marked on the floorplan. See sections 5.2 & 5.3

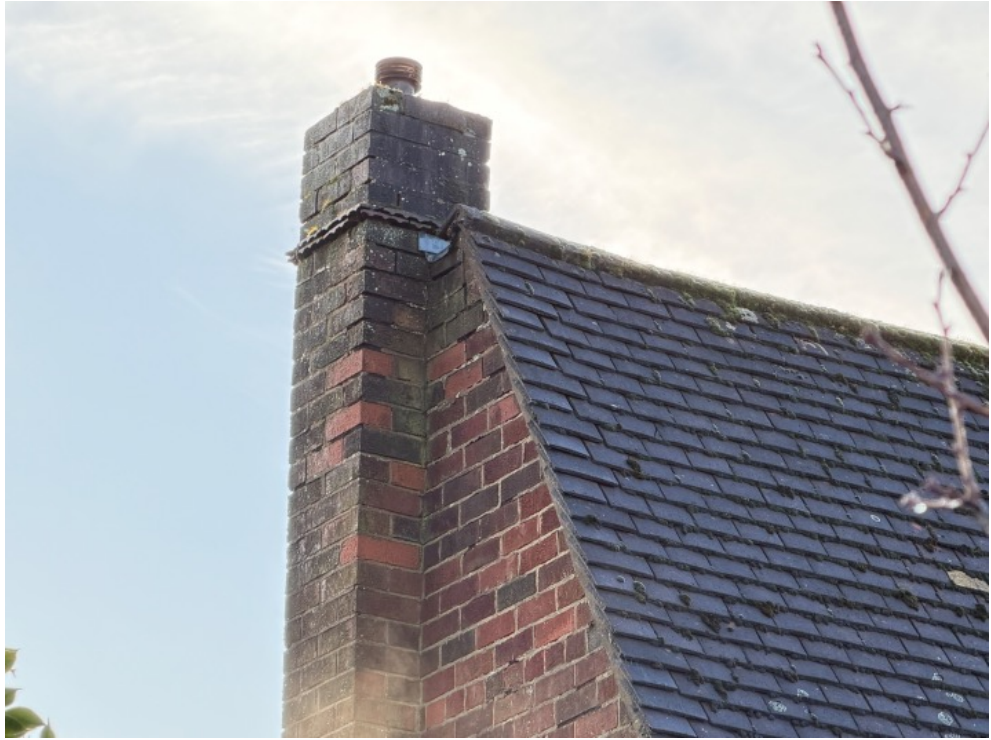
Left side chimney - vegetation and mortar missing

View of left side chimney

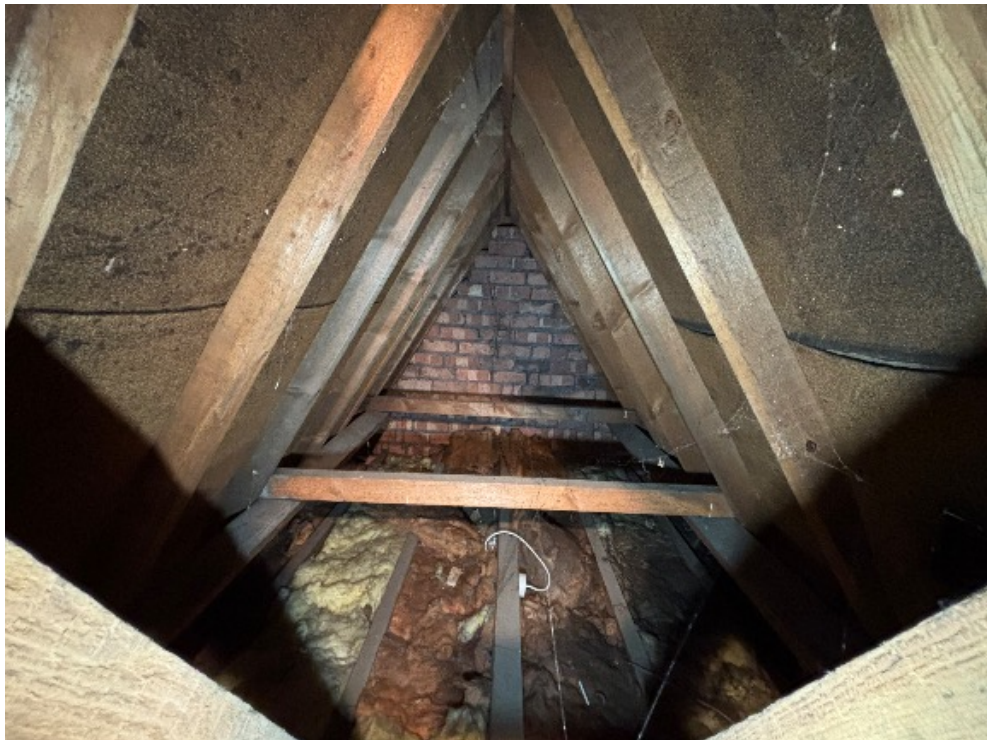
Evidence of nest behind roofing felt

General view of roof structure

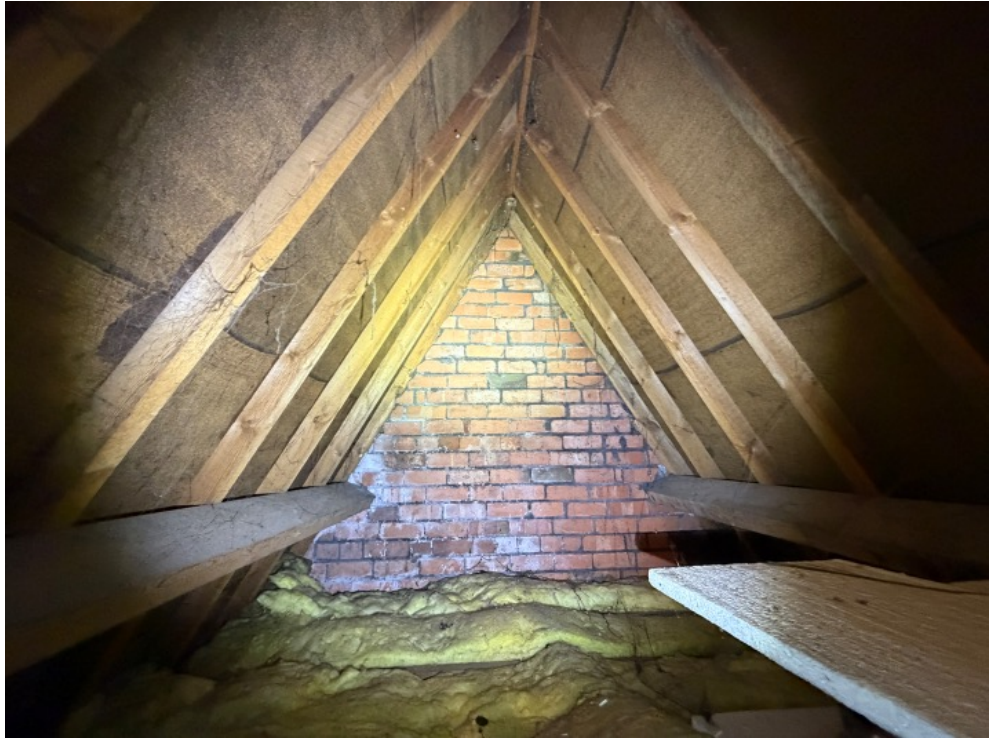
Water stained felt and roof timbers

General view of roof structure

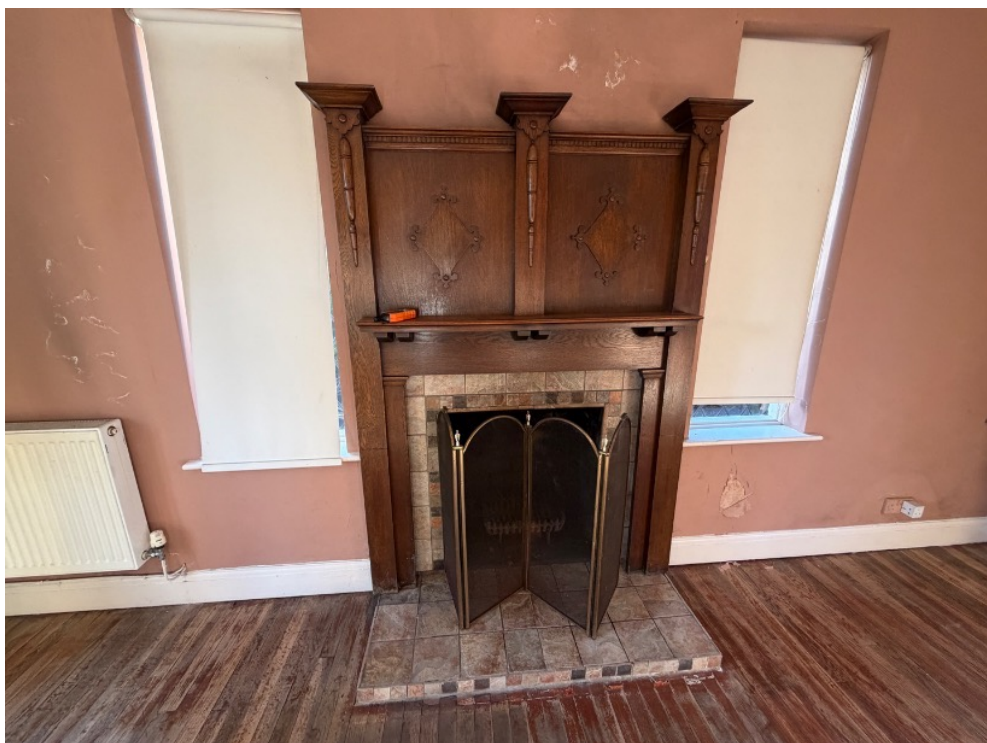
High moisture recorded in wall next to fireplace

View of fireplace

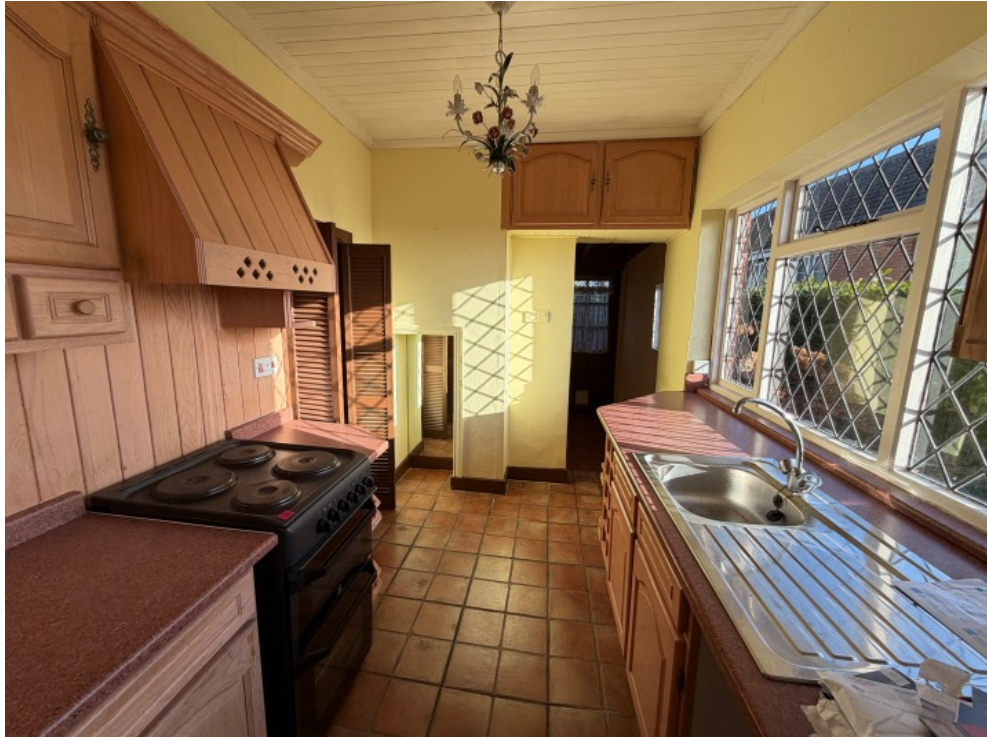
| <b>Condition</b> | <p>The fittings are of a dated style but serviceable condition.<br/>The flow of water at all outlets checked was within a normal range and considered to be suitable for the intended use.<br/>Hot water was obtained from all hot tap outlets.</p> <p>There is no mechanical ventilation, such as an extractor fan or cooker hood, in the kitchen. This increases the risk of condensation affecting the property. It is recommended that you install an extractor fan to improve ventilation.</p> <p>The damper pad fitted to the underside of the kitchen sink may be made of a material that contains small amounts of asbestos. See section 3.4. In its current state, it would not present any health risk if it did contain asbestos. It does not need to be removed, but should be disposed of correctly in the event that the sink is replaced.</p> | | |

View of kitchen

| <b>Action<br/>Required</b> | <p>It is recommended that a suitable mechanical extractor or cooker hood be installed to provide adequate ventilation in the kitchen. This should comply with current Building Regulations and ensure effective removal of moisture and cooking fumes. Regular cleaning and maintenance of the ventilation system are advised once installed.</p> <p>Maintain, repair or replace units as necessary.</p> | | |

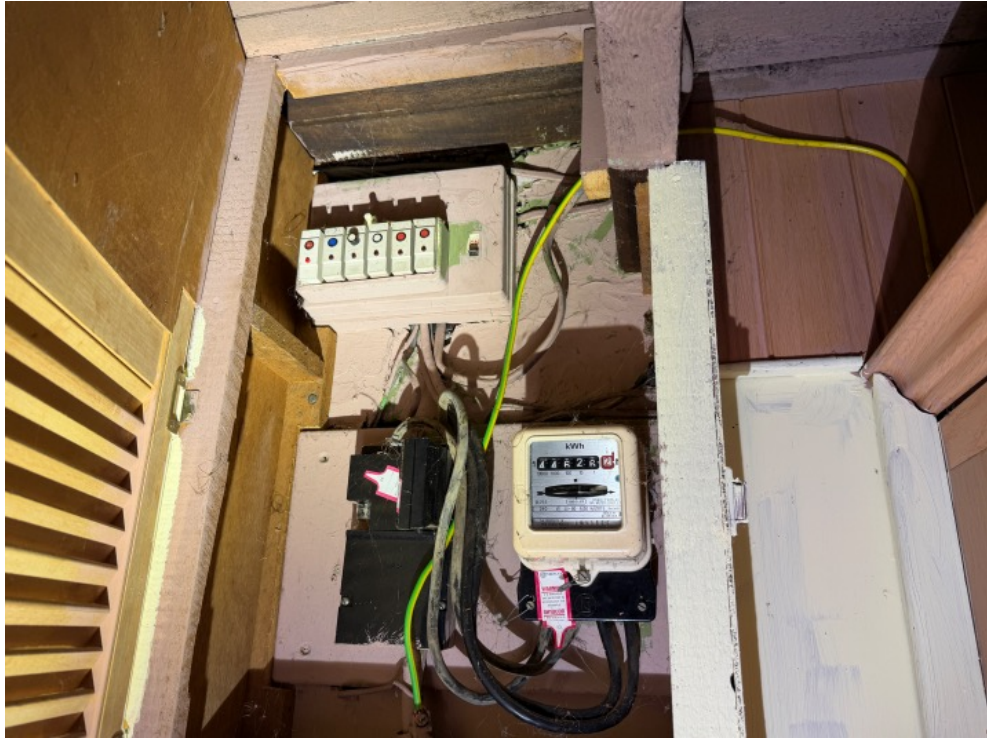
| <b>Condition</b> | <p>No evidence of broken, loose or damaged parts of the installation was seen, nor were any obvious amateur alterations or interventions noted. However, where furniture and other items are present, many of the outlets can be hidden from view.</p> <p>The consumer unit is in a timber housing. This is generally not recommended because timber is a combustible material. It is recommended that consumer units be installed in non-combustible housings, such as metal or plastic, that provide adequate protection from the elements and minimise the risk of fire.</p> <p>The property's electrical system incorporates cartridge fuses rather than modern circuit breakers. Cartridge fuses are considered outdated and offer less convenient protection against electrical faults compared to current standards. While functional, cartridge fuses do not provide the same level of protection or ease of replacement as modern consumer unit circuit breakers. They may increase the risk of electrical disruption and do not comply with current electrical installation standards for new installations.</p> <p><b>Observed Issues</b></p> <ul style="list-style-type: none"> <li>- The light fitting to the bathroom is not to current standards. All such fittings to bathrooms are required to have the correct Ingress Protection (IP) ratings for dust and moisture. A new fitting specifically designed for bathrooms should be installed.</li> </ul> | | |

Electric meter and consumer unit

| <p><b>Action Required</b></p> | <p>NAPIT recommends that domestic electrical installations be inspected and tested every 10 years in line with IET (The Institution of Engineering &amp; Technology) Guidance Note 3 covering Electrical Installation Condition Reports (EICR). This guidance also recommends that at any change of occupancy (such as a house sale or change of tenant) an Electrical Installation Condition Report is carried out to prove the installation to be in a satisfactory or unsatisfactory condition. This report should cover all the fixed wiring and equipment within the property boundaries, including outbuildings.</p> <p>You can get further information from Electricity Safety First at <a href="https://www.electricalsafetyfirst.org.uk/guidance/safety-around-the-home/">https://www.electricalsafetyfirst.org.uk/guidance/safety-around-the-home/</a></p> <p>Any electrical works carried out should have been completed by a Registered Competent Person (Electrical) and, as such, would have provided a Minor Electrical Installation Works Certificate, or an Electrical Installation Certificate, and in addition a Building Regulation Compliance Certificate where required.</p> <p>At the time of the survey, no documentation was seen to verify that an inspection has been carried out within the last 10 years, and the installation must therefore be considered to be in a potentially dangerous and unsatisfactory condition.<br/>This is the reason for the HS rating in this section.<br/>An electrical installation can look to be in a safe condition, but serious defects may be hidden within the walls or under floors. It is therefore considered to be essential that you commission an inspection and testing of the electrical installation prior to purchase of the property, unless you are provided with verifiable evidence that such an inspection has recently been carried out by a registered competent person (electrical)</p> <p>There is no legal requirement on the seller of a house to provide an up-to-date Electrical Installation Condition Report. Whilst it is not unreasonable to ask the seller to provide evidence of the condition of the electrical installation, they are under no obligation to do so.</p> <p>Consideration should be given to replacing the timber housings with modern, non-combustible alternatives to improve safety and compliance with current standards. Regular inspection and maintenance of the electrical system should continue in the interim.</p> <p>It is recommended that the electrical system be inspected by a qualified electrician, and consideration be given to upgrading the consumer unit and protection to modern circuit breakers to improve safety and compliance with current standards. Regular testing and inspection should be maintained in the interim.</p> <p>Bathroom light fittings should be replaced with appropriately IP-rated units suitable for use in wet or damp areas. A qualified electrician should carry out the replacement to ensure compliance with current regulations. Regular inspection of electrical installations in the bathroom should be undertaken as part of ongoing maintenance.</p> |

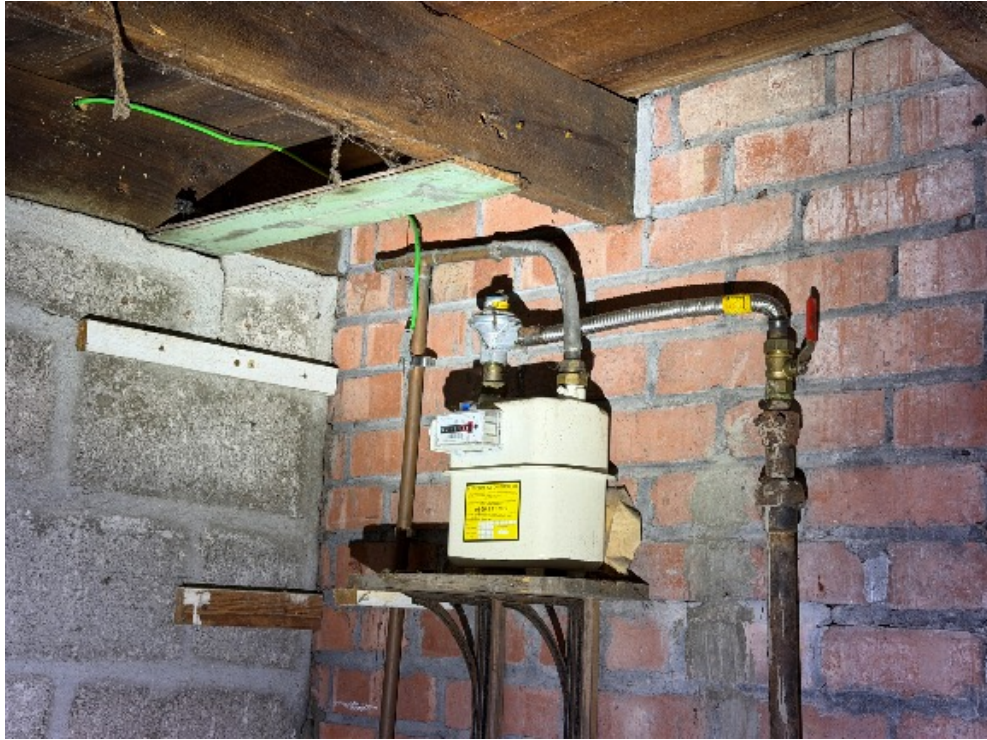
| <b>Condition</b> | No significant defects were noted, but see also the recommendation in 6.4 Heating with regard to a full test and inspection. | | |

Gas meter

| <b>Action<br/>Required</b> | <p>Monitor the meter and valve for signs of corrosion or degradation.</p> <p>As the property is empty, parts of the system may not have been in use for a while. These observations increase the risk of any hidden issues. Further advice should be obtained as to the operational safety of the complete system.</p> <p>The Gas Safe website, called 'Buying a new home', it states:<br/>'Homebuyers cannot always be sure when the gas appliances in their new home were last safety checked and serviced. Ask your vendor for an annual gas safety record, which shows that a Gas Safe registered engineer has checked the gas appliances. If your vendor cannot supply an up-to-date annual gas safety record, you should get a Gas Safe registered engineer to check the gas appliances before you move in. This check should include the gas boiler, oven, hob and gas fire. The registered engineer will give the vendor a gas safety record, which they should handover to you before you move in. Better Gas Safe than sorry. Poorly maintained or badly fitted gas appliances can put you at risk from gas leaks, explosions, fires and carbon monoxide poisoning.'</p> <p>'Safety check' - As a minimum, this must check:</p> <ul style="list-style-type: none"> <li>•Appliances are positioned in the right place;</li> <li>•Any flue or chimney serving appliances are safe and installed correctly;</li> <li>•There is a good supply of combustion air (ventilation) to appliances;</li> <li>•The appliances are on the right setting and are burning correctly; the appliances are operating correctly and are safe to use.</li> </ul> | | |

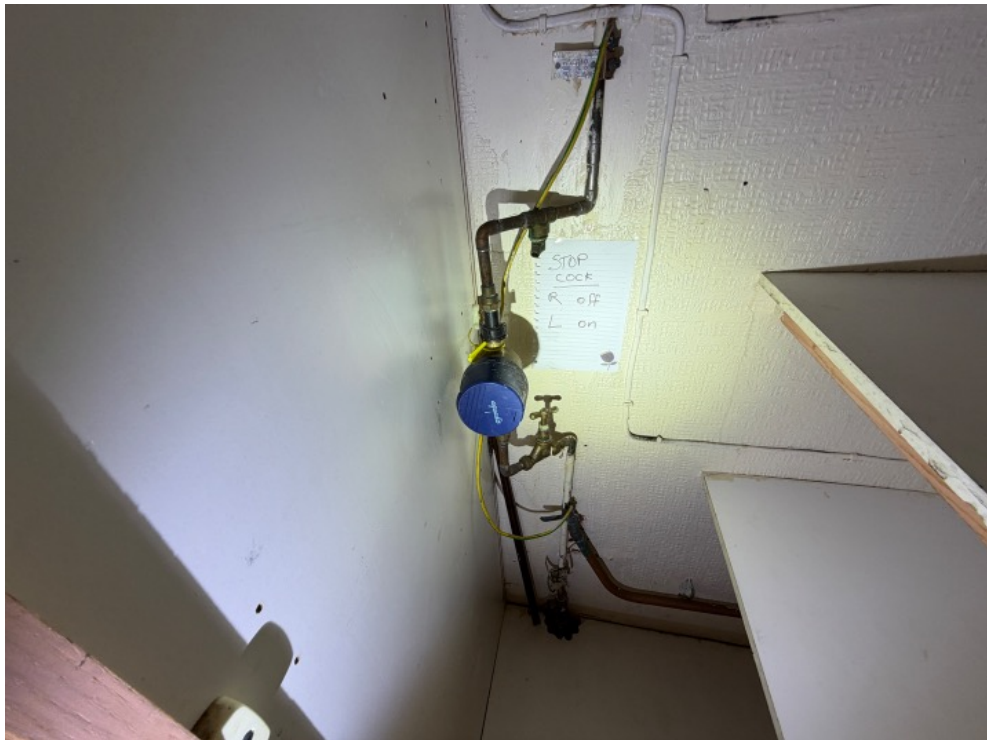
| <b>Condition</b> | <p>No significant defects were noted.</p> <p>The flow of water at all outlets was found to be within a normal range.</p> <p>The property is fitted with a combination (or "combi") boiler. Unlike a traditional domestic system, there are no hot or cold water tanks, and mains water is heated directly by the boiler to supply hot water to taps and radiators. When the incoming water temperature is lower, for example in winter, it will take longer to heat water to the same temperature as in the summer, and so the flow rate, at taps and other outlets, will be reduced. Similarly, when more than one water outlet within the property is operated at the same time, the flow rate will drop.</p> <p>It is also common, when a combi boiler is installed, to experience a delay before hot water reaches tap outlets. The reason is that all the water sitting in the boiler's heat exchanger, and in the pipe run between the boiler and tap, has to be expelled before warm water flows through.</p> | | |

Incoming water main

| <b>Action<br/>Required</b> | <p>Check the installation for evidence of leaks or other defects on a regular basis i.e. approximately every 6 months, or sooner. Leaks most often occur at pipe joints and where pipes are subject to movement or physical damage, such as airing cupboards, roof spaces and under sinks.</p> | | |

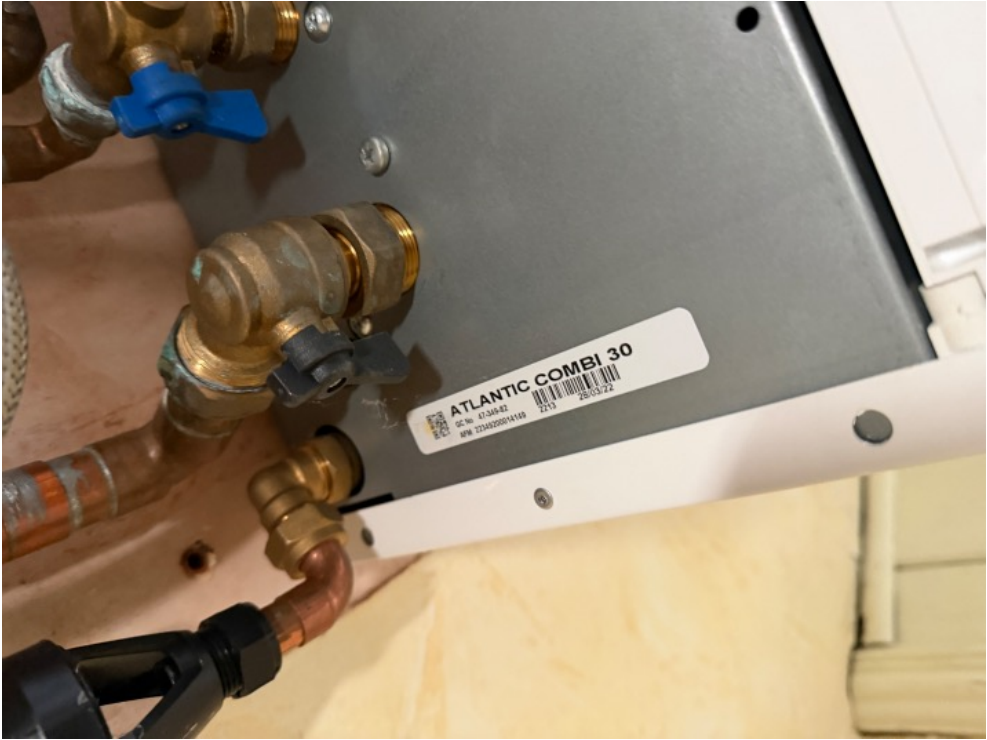
| | <b>6.4 Heating and Cooling</b> | <b>Condition<br/>rating</b> | <b>HS</b> |
|---|---|---|---|
| <b>Condition</b> | <p>COMBI - The boiler and radiator system was in operation during the survey, and radiators were warm to the touch. When hot taps were checked, hot water was delivered. The water pressure in the radiator circuit is at 2 bar, which is higher than required.</p> <p>No visible repairs were noted. We would recommend seeing the results of the boiler servicing, which should include an inspection of the flue, and observing the boiler and radiator system in full operation with radiators becoming warm to the top and bottom.</p> <p>No evidence was seen to suggest that an inhibitor has been added to the heating system recently to prevent a build-up of sludge in the pipework and radiators, and it is therefore recommended that the system be flushed through and an inhibitor added.</p> <p>Note: Combination boilers can only provide hot water to one appliance at a time (usually the appliance closest to the boiler). Consequently, if there is more than one demand for the boiler at a time, the appliances further away can get reduced levels of hot water. It can also take longer to fill a bath than with a traditional system.</p> <p>Condensing boilers produce a slightly acidic waste product called condensate, which is removed via a white plastic pipe to an external drain. If the pipe becomes blocked, perhaps by liquid freezing within it, it can cause the boiler to shut down.</p> <p>A historic leak from a radiator pipe in the hallway, adjacent to the W/C, has resulted in timber decay. Evidence of wood-boring beetle activity has also been observed in the affected timber (see section 5.4). The leak appears to have been resolved, but residual damage remains. The decay and beetle infestation compromise the structural integrity of the affected timber.</p> | | |

| | <p>Boiler badge</p> |

| <p><b>Action Required</b></p> | <p>Gas Safe recommends that all gas appliances and boilers be inspected and serviced according to the manufacturer's guidance, but at least once a year. A gas installation can look to be in a safe condition, but serious defects may be hidden, some of which can kill. It is therefore considered to be essential that you commission an inspection of the gas/heating installation prior to purchase of the property, unless you are provided with verifiable evidence that such an inspection has recently been carried out by a competent person.</p> <p>You can get more information, or find a Gas Safe registered engineer <a href="https://www.gassaferegister.co.uk/find-an-engineer/">https://www.gassaferegister.co.uk/find-an-engineer/</a></p> <p>Consideration should be given to the replacement or treatment of the damaged timber beneath the previously leaking radiator pipe and appropriate insecticide treatment to eradicate beetle activity. Ongoing monitoring is advised to ensure that the infestation does not spread.</p> <p>Flush through radiator system and add inhibitor</p> <p>No visible repairs were noted; normal maintenance servicing must be continually undertaken.</p> <p>Health and Safety – See also notes in 6.2 regarding the general safety and servicing of the complete Gas system.</p> |

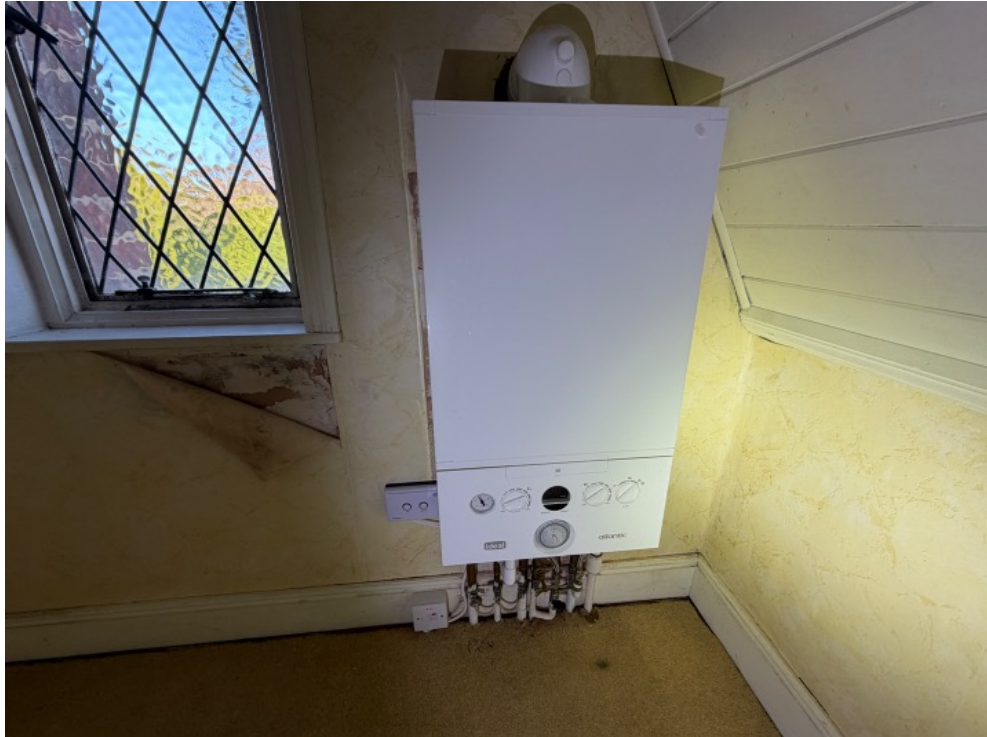
Boiler

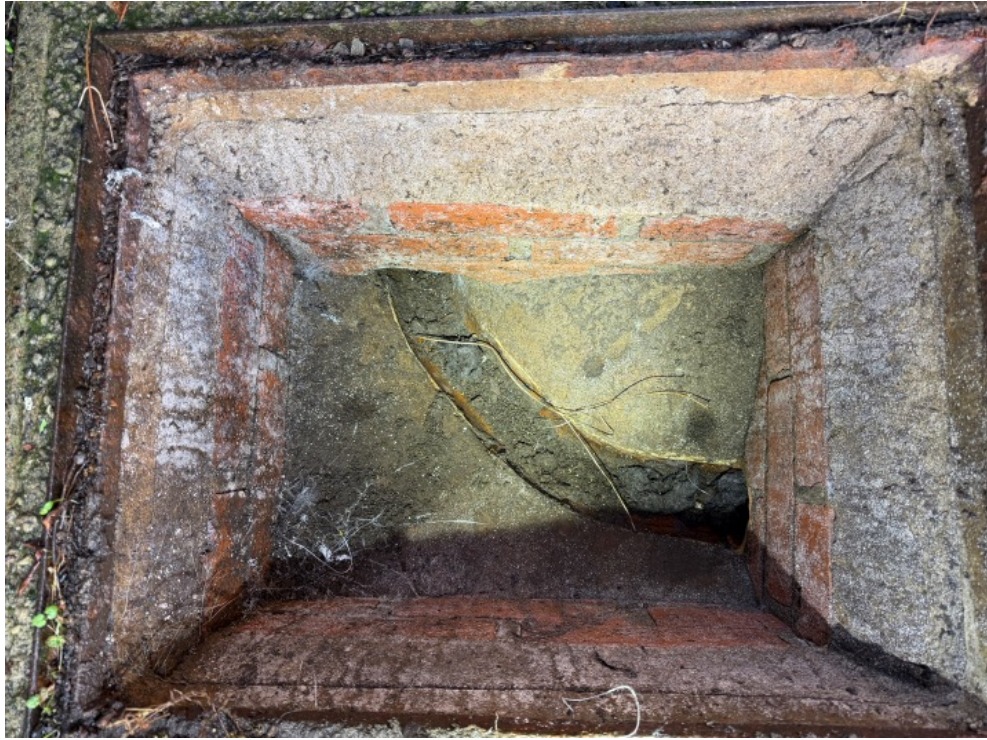
| <b>Condition</b> | <p>Silt and blockages have been observed within the inspection chamber at the rear of the property. The accumulation of debris is restricting the flow of surface and wastewater through the drainage system. If left unaddressed, the blockages could result in slow drainage, ponding, or localised flooding. Continued restriction may place additional strain on the drainage system and increase the risk of water ingress to the building or damage to external finishes.</p> | | |

View down drain chamber

| <b>Action<br/>Required</b> | <p>Drains should be regularly inspected to ensure they remain free from blockages, such as tree root damage or other obstructions.</p> <p>It is often suggested that the manholes only allow inspection of 5-10% of an entire drainage installation. As such, it is entirely possible that damage can be present within the system, but it would not be apparent from opening the manholes.</p> <p>The only way to confirm the condition of the whole installation is to commission a CCTV inspection from a qualified contractor, for example a member of the National Association of Drainage Contractors at <a href="http://www.nadc.org.uk/">www.nadc.org.uk/</a></p> <p>It is recommended that a full drainage inspection, such as a CCTV survey, be undertaken by a qualified drainage contractor to identify the extent of blockages and any underlying defects. The inspection chamber and associated drainage system should be cleared and maintained as necessary. Regular monitoring and maintenance are advised to prevent recurrence.</p> | | |

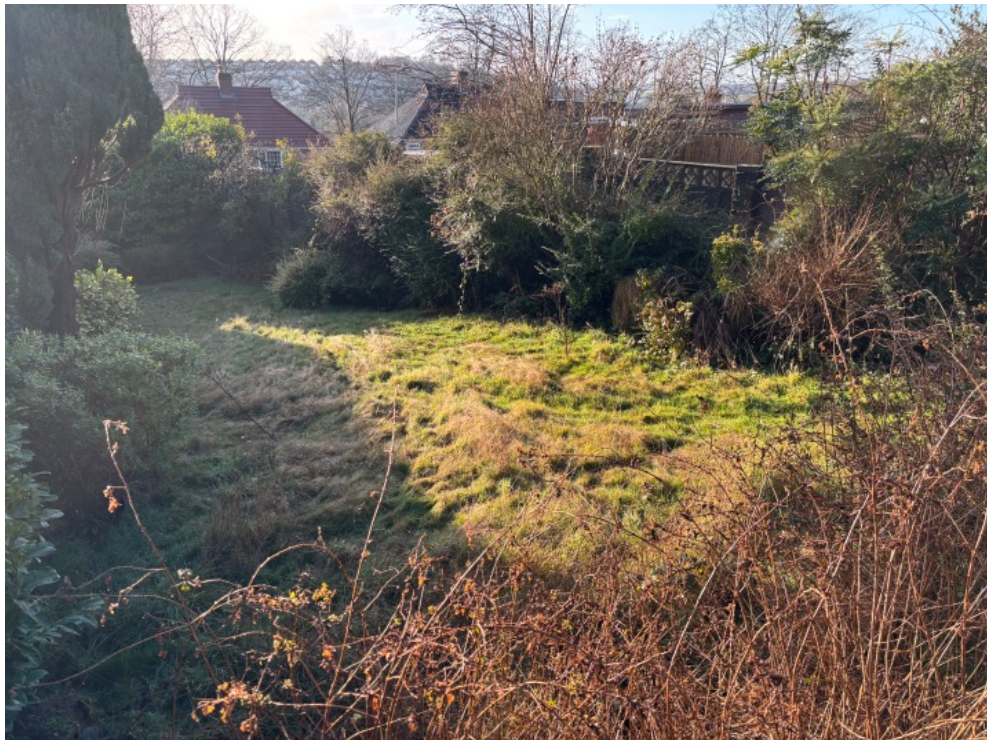
View of rear garden

| <p><b>Action Required</b></p> | <p>It is recommended that loose and damaged slabs be lifted and relaid or replaced as necessary to provide a level and stable surface. Vegetation should be removed, and appropriate measures taken to prevent regrowth. Regular maintenance of the patio area is advised to reduce the risk of further deterioration and safety hazards.</p> <p>The shrubs should be regularly pruned and maintained to prevent excessive growth and to ensure adequate clearance from the building fabric. Ongoing grounds maintenance should be anticipated as part of ownership to manage future risks and preserve the condition of the property.</p> <p>It is strongly recommended that a suitable safety railing or guarding be installed to the patio edge to reduce the risk of falls. The design and installation should comply with current Building Regulations and relevant safety standards. This matter should be addressed as a priority.</p> <p>Consideration should be given to repairing or replacing affected timber panel fencing as necessary. All timber fencing should be treated with a suitable preservative to improve durability and prolong service life. Ongoing maintenance should be anticipated to prevent further decay.</p> <p>It is recommended that the pillars be inspected more closely to determine the cause of movement. Remedial works may include realigning, stabilising, or rebuilding the pillars and ensuring foundations are sound. Regular monitoring is advised to assess if further movement occurs.</p> |
